TEST REPORT FOR FIRE PROPAGATION CHARACTERISTICS OF EXTERIOR WALL ASSEMBLIES

4mm thick WELLBOND-A2 Aluminium Composite Panel (ACP) Cladding Assembly.

NFPA 285: Standard Fire Test Method for Evaluation of Fire Propagation Characteristics of Exterior Wall Assemblies Containing Combustible Components, 2019 Edition.

Test Reference No: WC157-1

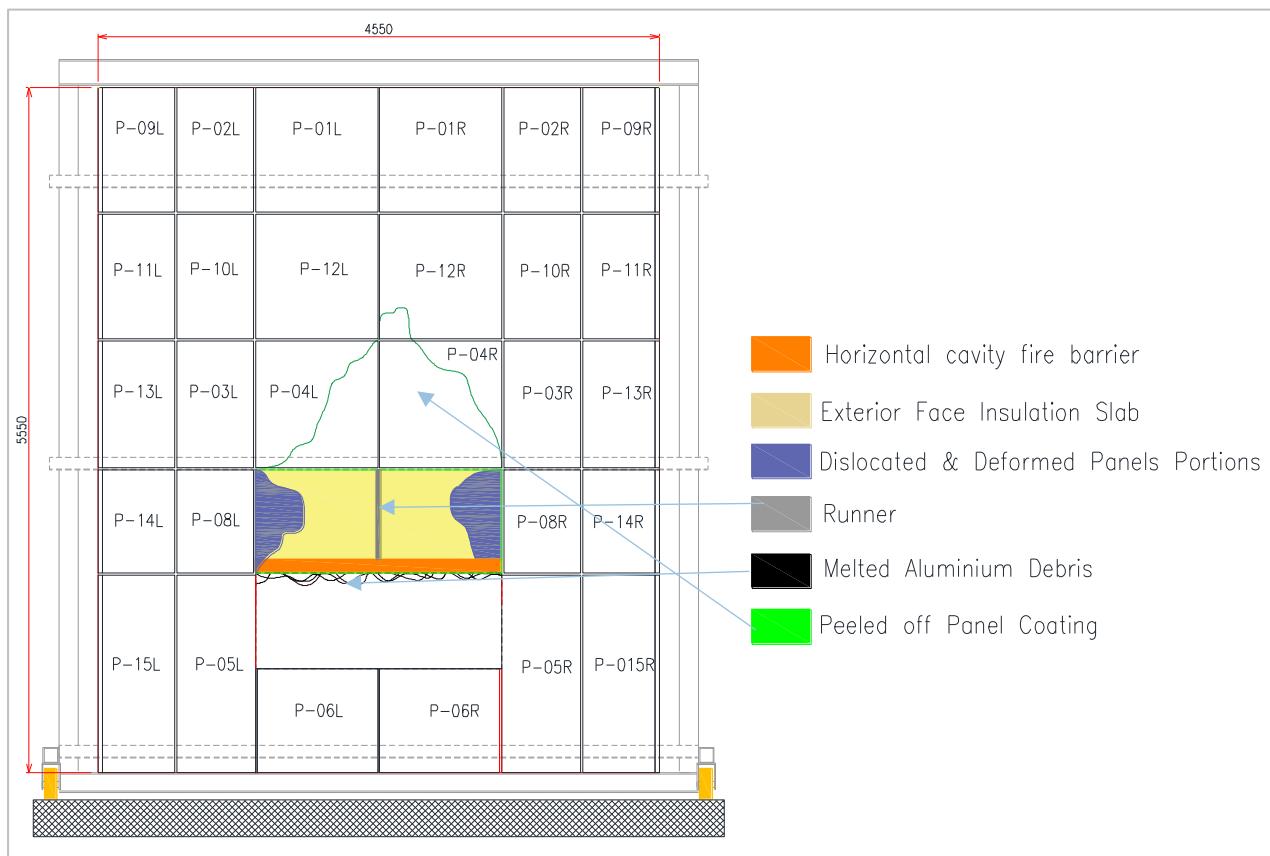
Sketch 1: Sketched view of the assembly after the test.

Soot stains were observed centrally along the height of the specimen from the window head. Mineral wool insulation was exposed up to approximately 2.5 feet above the window head. The horizontal cavity fire barrier located just above the window head was exposed and slightly damaged. The base of the horizontal cavity fire barrier located at 3 feet above the window head was visible. The ACP coating had peeled off till a maximum height of 6.5 feet above the window head. Window flashing had completely deformed, melted and were barely in place.

Damage was largely limited to the window head section and upon removal of the remaining intact panels around the exposed area, high smoke damage was observed on the backside of the panels 07L & 07R. Light smoke stains were observed on the top horizontal cavity fire barriers.

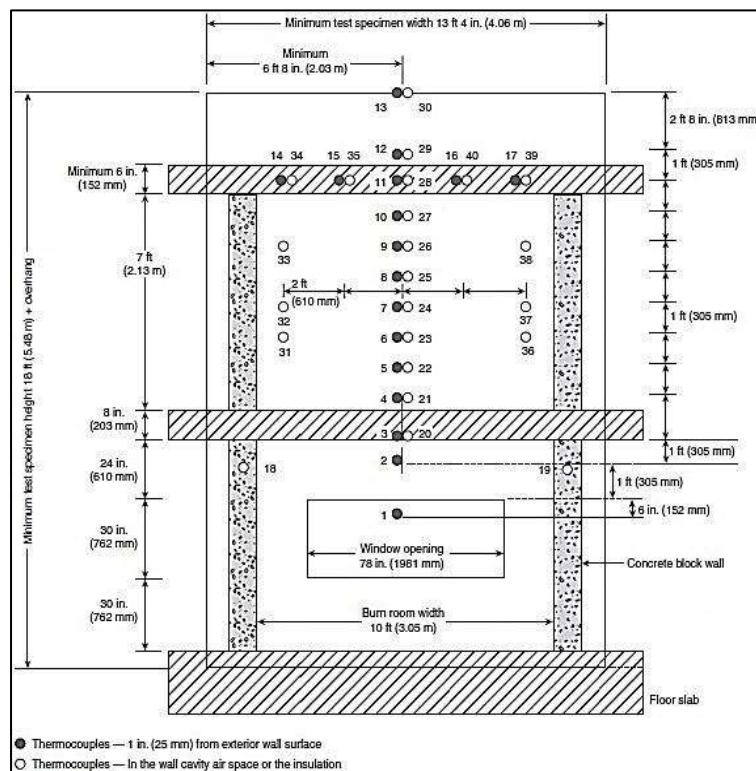
Figure 1: Overall instrumentation on the exterior wall surface and air cavity.

A total of 54 Type-K thermocouples were used on the specimen, with all interior thermocouples fixed within the specimen placed at mid-depth of the air cavity (92mm), nominally 220mm from the interior face of the base wall, as per figure 6.1(b), Detail H in the NFPA 285 standard, shown in Appendix 1, Figure 4 of this report.

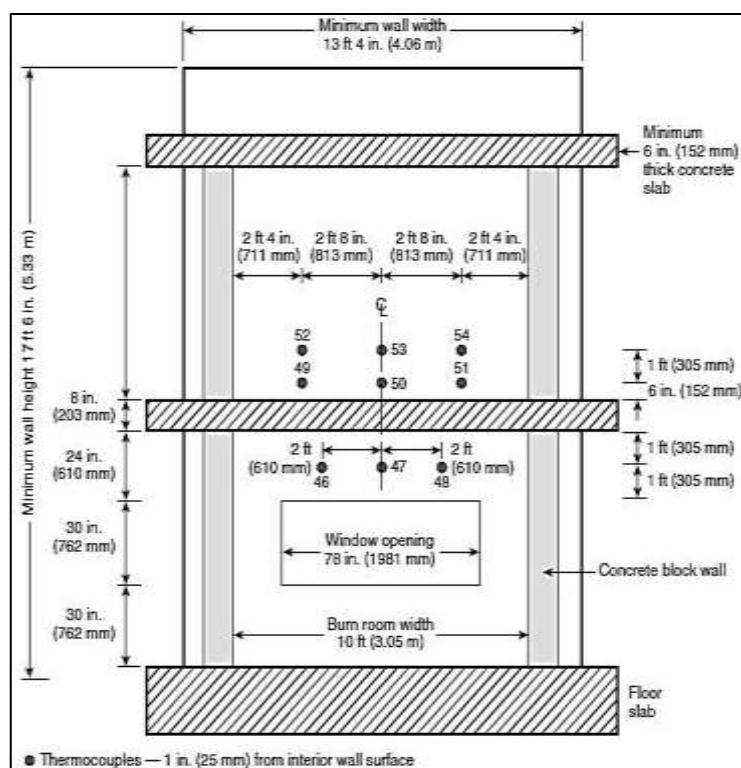
Figure 2: Overall instrumentation on the interior wall

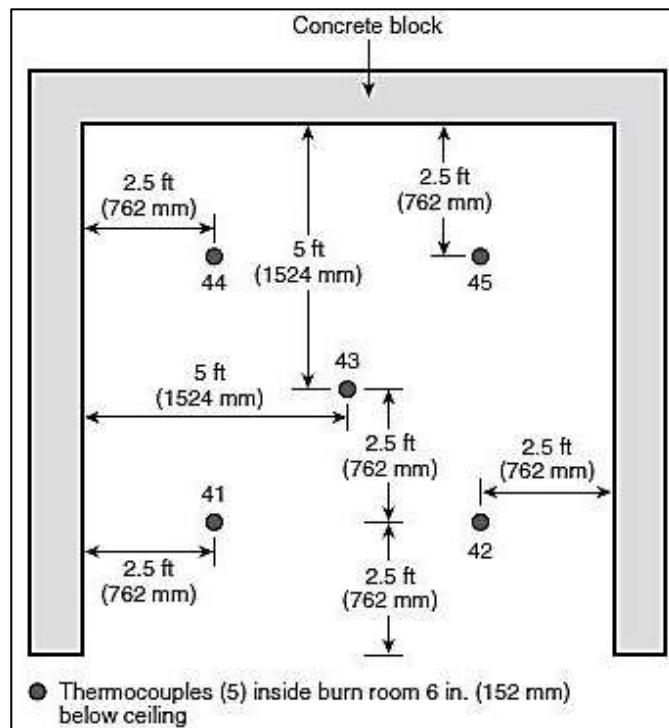
Figure 3: Overall instrumentation inside of the 1st story burn room (Top View)

The burn room thermocouples were placed at 6 inches below the first story test room ceiling and distributed according to NFPA 285; Fig. 6.1(d).

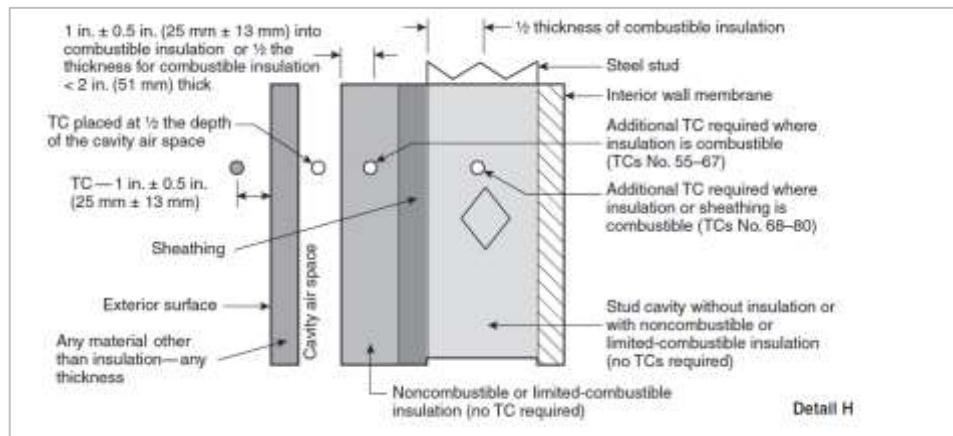
Figure 4: Figure 6.1(b) Detail H of the NFPA 285 standard, showing the thermocouple depth specifications of the specimen.

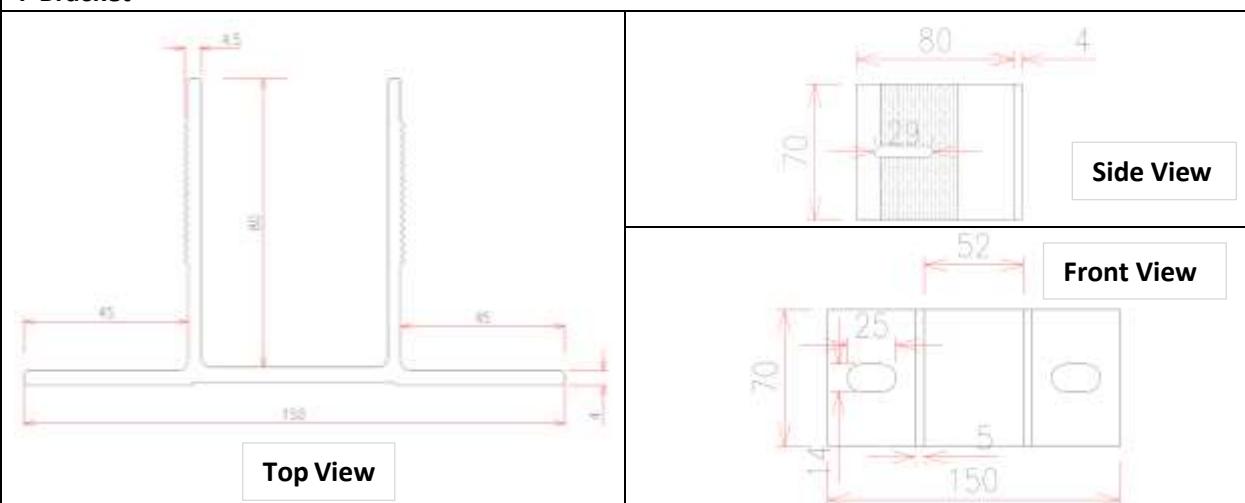
T-Bracket

T- Brackets	Fasteners
Material	Aluminium*	Galvanized Steel*
Alloy/Grade	6063-T6*	5*
Manufacturer	WELLBOND*	TUF-FIX
Reference	Aluminium Wall Bracket*	Hex. Head Self-Tapping
Dimension	As shown above 2.5mm thick	Ø6 x 50mm
Fixing Method	The T-brackets were fixed onto the studs via exterior face of the base wall using two nos. of Ø6 x 50mm long stainless-steel hexagonal head self-tapping screws with washer which were spaced nominally 100mm apart. (For layout and spacing refer to drawing 3 in Appendix 4).

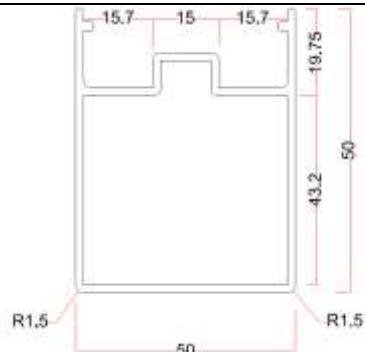
Runner	Fasteners
Material	Aluminium*	Galvanized Steel*
Alloy/Grade	6063-T6*	5*
Manufacturer	WELLBOND*	TUF-FIX
Reference	Runner Profile WG 5050	Hex. Head Self-Tapping
Dimension	As shown above 2mm thick	Ø6 x 25mm
Fixing Method	The runners were fixed within the wall brackets on either side using two nos. of stainless-steel hexagonal head bolts of dimensions Ø6 x 25mm supported with washer. (Refer to drawing 4 in Appendix 4 for reference).

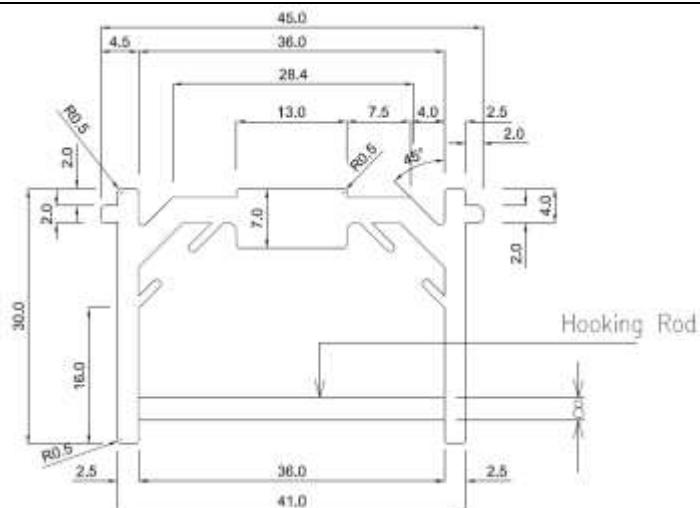
Hook Holder	Fasteners
Material	Aluminium*	Galvanized Steel*
Alloy/Grade	6063-T6*	5*
Manufacturer	WELLBOND*	TUF-FIX
Reference	Hanging Profile WG 5049	Pan-head screw
Dimension	As shown above 2.5mm thick	Ø4 x 19mm
Fixing Method	The hook holders were slotted into the runner profiles and were partially fixed in place with the support of stainless-steel grub screws of size Ø5 x 16mm. Once the panels are hooked onto the hook holders and aligned properly, the hook holders were further strengthened in place by using a pan head screw of size Ø4 x 19mm onto the runner via the face of the hook holder.

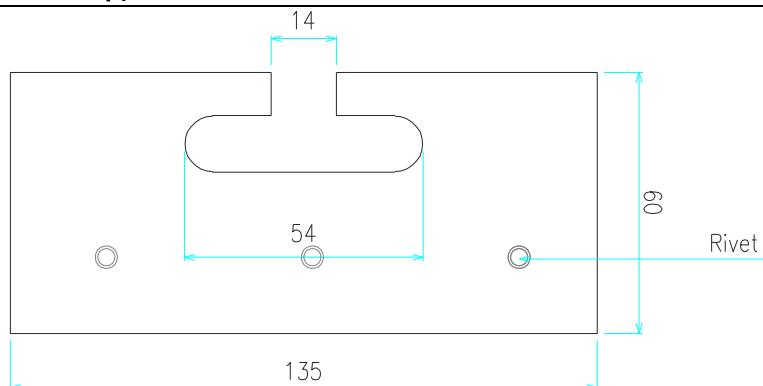
Panel Hook (Aluminum Strip)

Panel Hook	Rivet
Material	Aluminum*	Stainless Steel
Alloy/Grade	6063-T6*	314
Manufacturer	WELLBOND	Retail
Reference	Hook Profile*	Blind rivet
Dimension	As shown 3mm thick	Ø4 x 16mm
Fixing Method	The hook brackets were pre-fixed onto the flanges of the panels with the support of three nos. of blind rivets of size Ø4 x 14mm. The hook brackets were spaced at a nominal distance of 360mm c/c and 85mm from the ends.

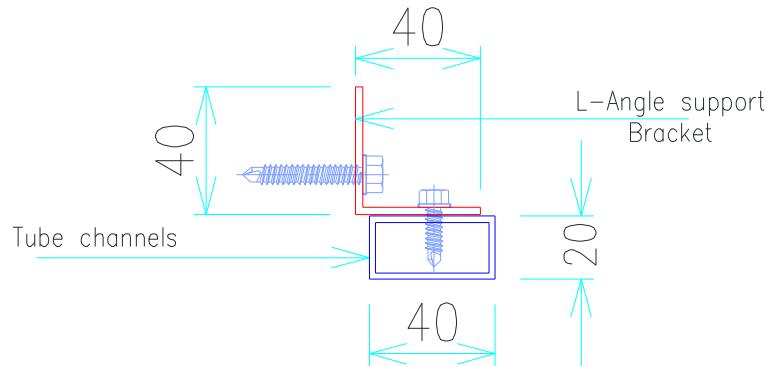
Window Perimeter Framing

Tube Channel	L-Angle Support
Material	Aluminium*	Aluminium*
Alloy/Grade	6063-T6*	6063-T6*
Manufacturer	WELLBOND*	WELLBOND*
Reference	1.5mm thick Aluminium Tube	2mm thick Aluminum angle
Dimension	As shown above 1.5mm thick	As shown above 2mm thick 150mm long
Fixing Method	The tube channels were cut to required lengths and were fixed along the perimeter edge of the window opening and the specimen on the exterior face of the base wall such that there was an offset of 5mm from the window opening edges. The tube channels were fixed with the support of L-angle support brackets. The L-bracket was fixed onto the tube channels via stainless-steel hexagonal head bolts of dimensions Ø6 x 25mm. Two nos. of L-angle support brackets were used along the vertical edges of the tube channels and three nos. of brackets were used along the horizontal edges of the tube channels and they were fixed in place via stainless-steel hexagonal head bolts of dimensions Ø6 x 50mm. The brackets were spaced at a nominal distance of 760mm c/c vertically and 990mm c/c horizontally.

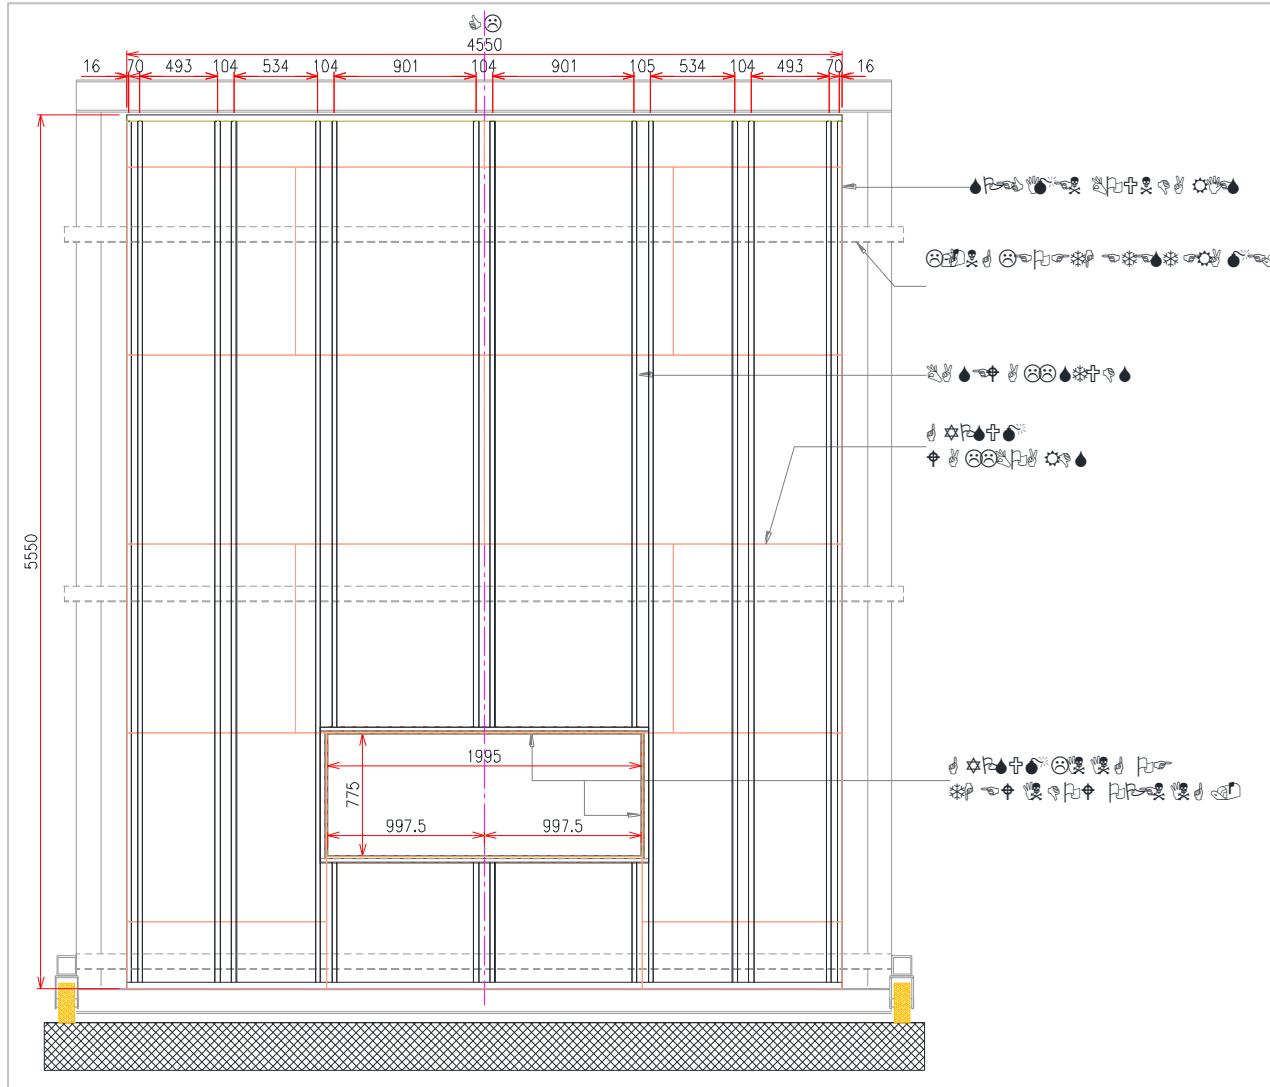
Drawing 1: Elevation view of the test specimen.
(Drawing provided by test sponsor)

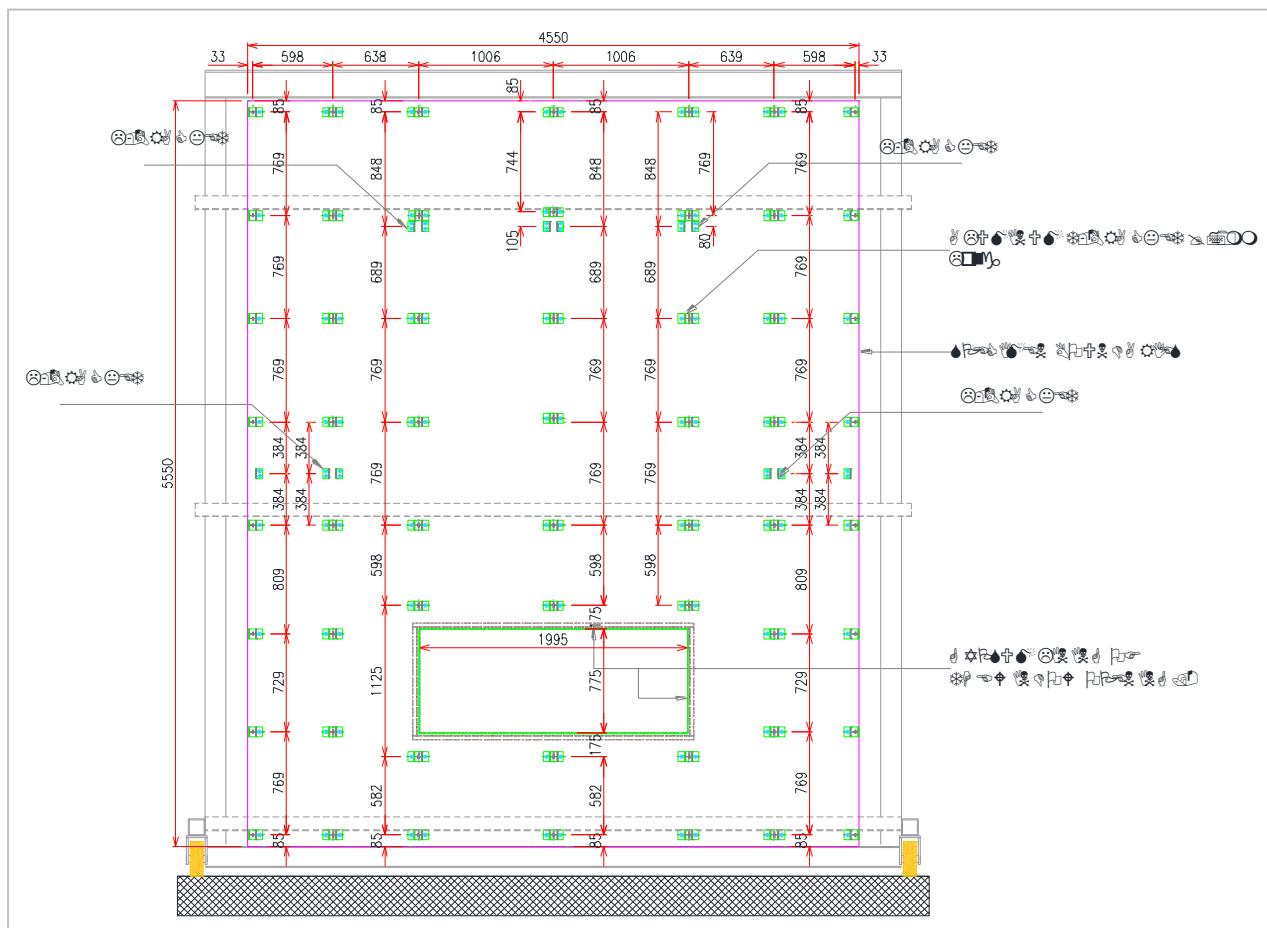
Drawing 3: Elevation view of the wall brackets layout.
(Drawing provided by test sponsor)

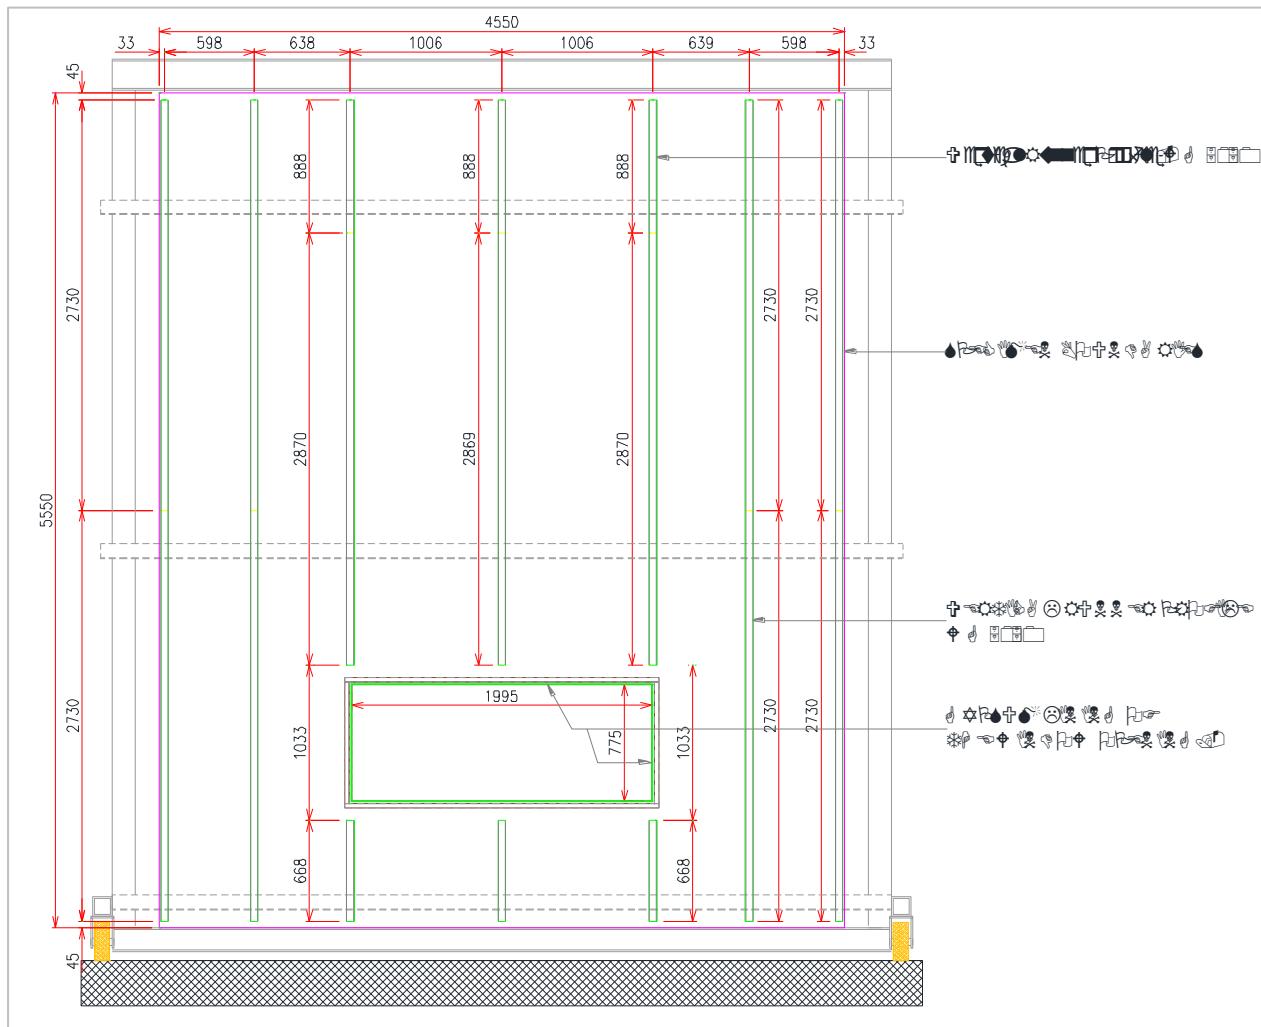
Drawing 4: Elevation view of the runner layout.
(Drawing provided by test sponsor)

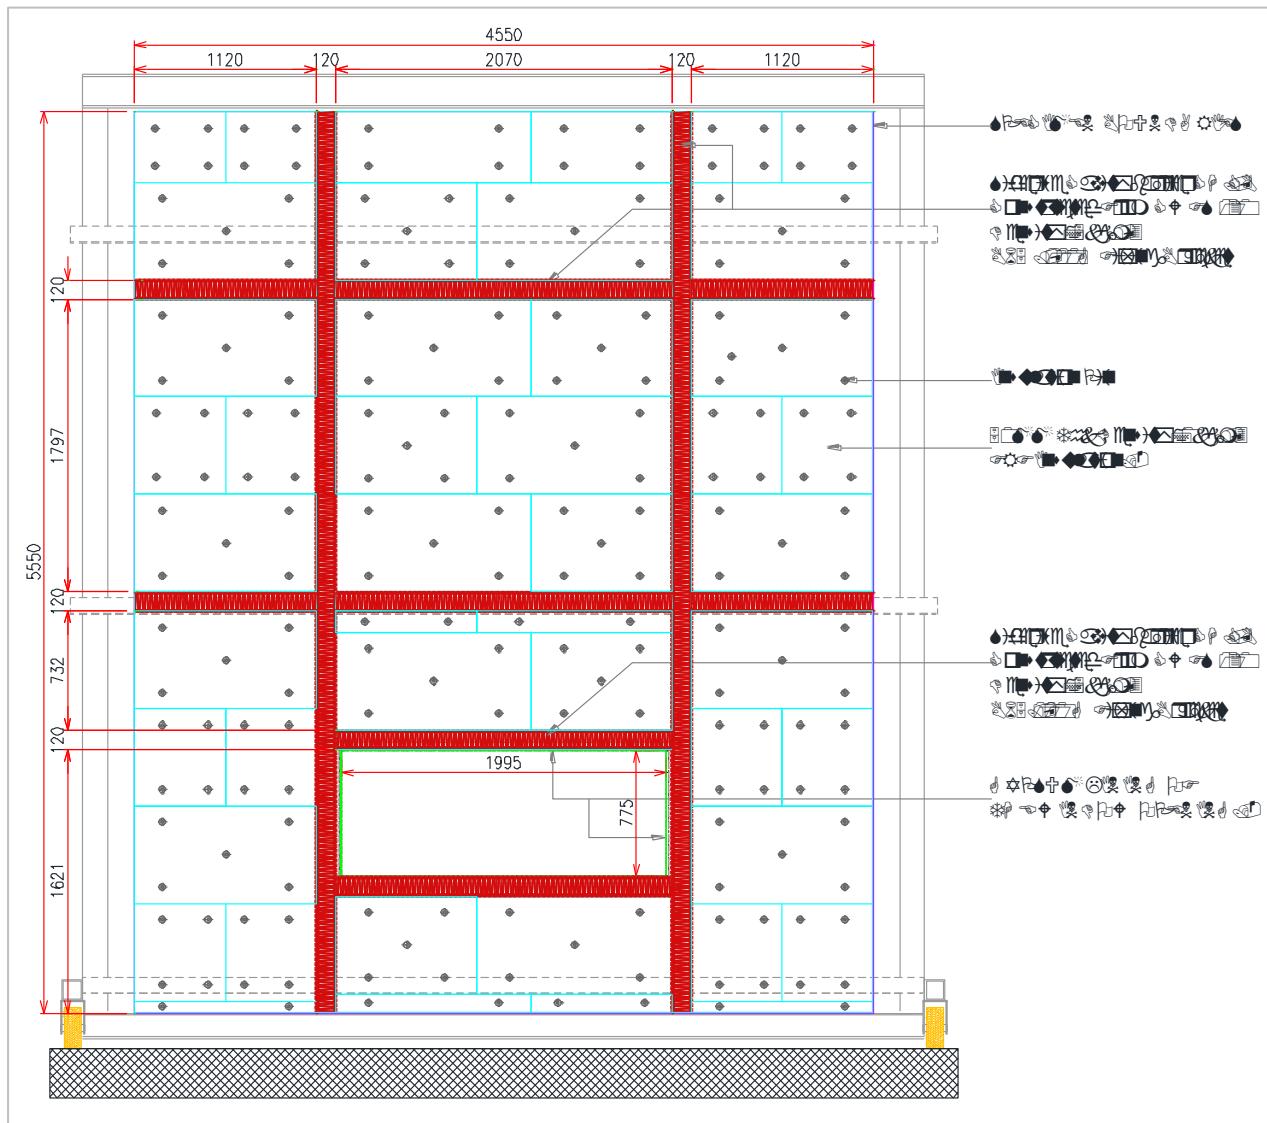
Drawing 5: Elevation view of the insulation system.
(Drawing provided by test sponsor)

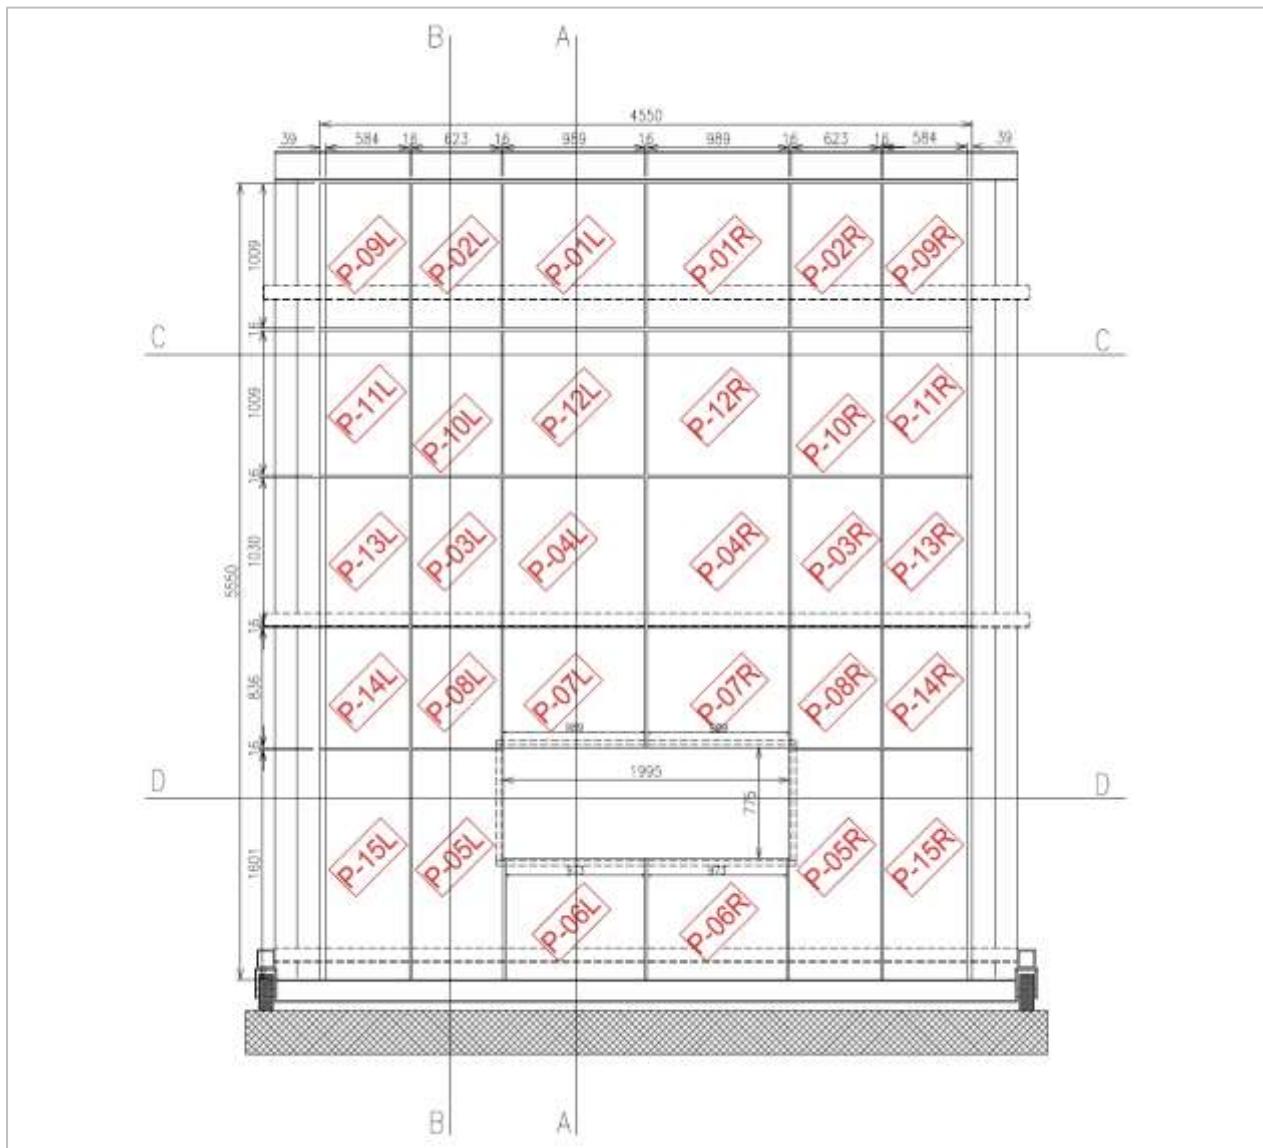
Drawing 6: Elevation view of the completed cladding assembly.
(Drawing provided by test sponsor)

Time (mm:ss)	Observations From in Front of the Specimen (Exterior Face) <i>Heights referenced are from the head of the window opening, unless otherwise stated. Note: For panel location & reference, see drawing 6 in Appendix 4</i>

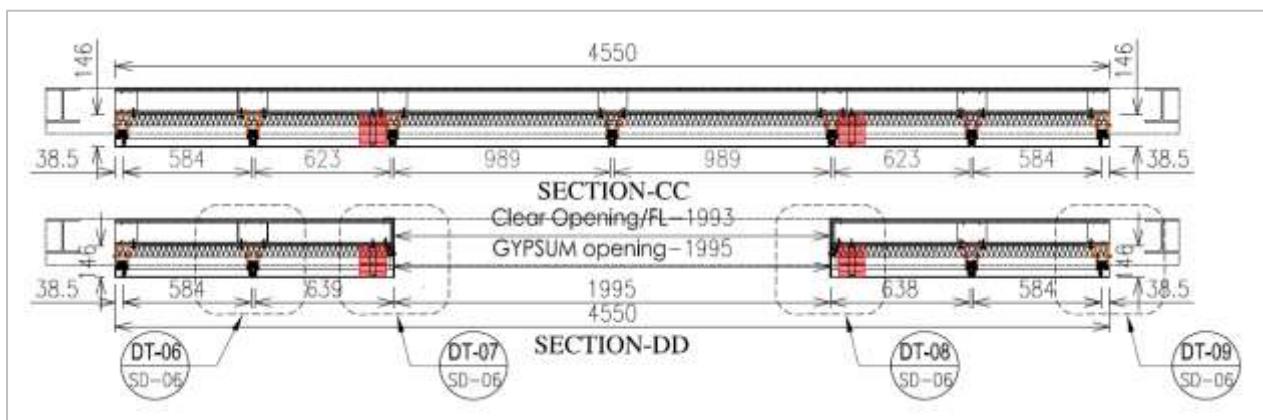
Drawing 7: Horizontal sectional views of drawing 5.
(Drawing provided by test sponsor)

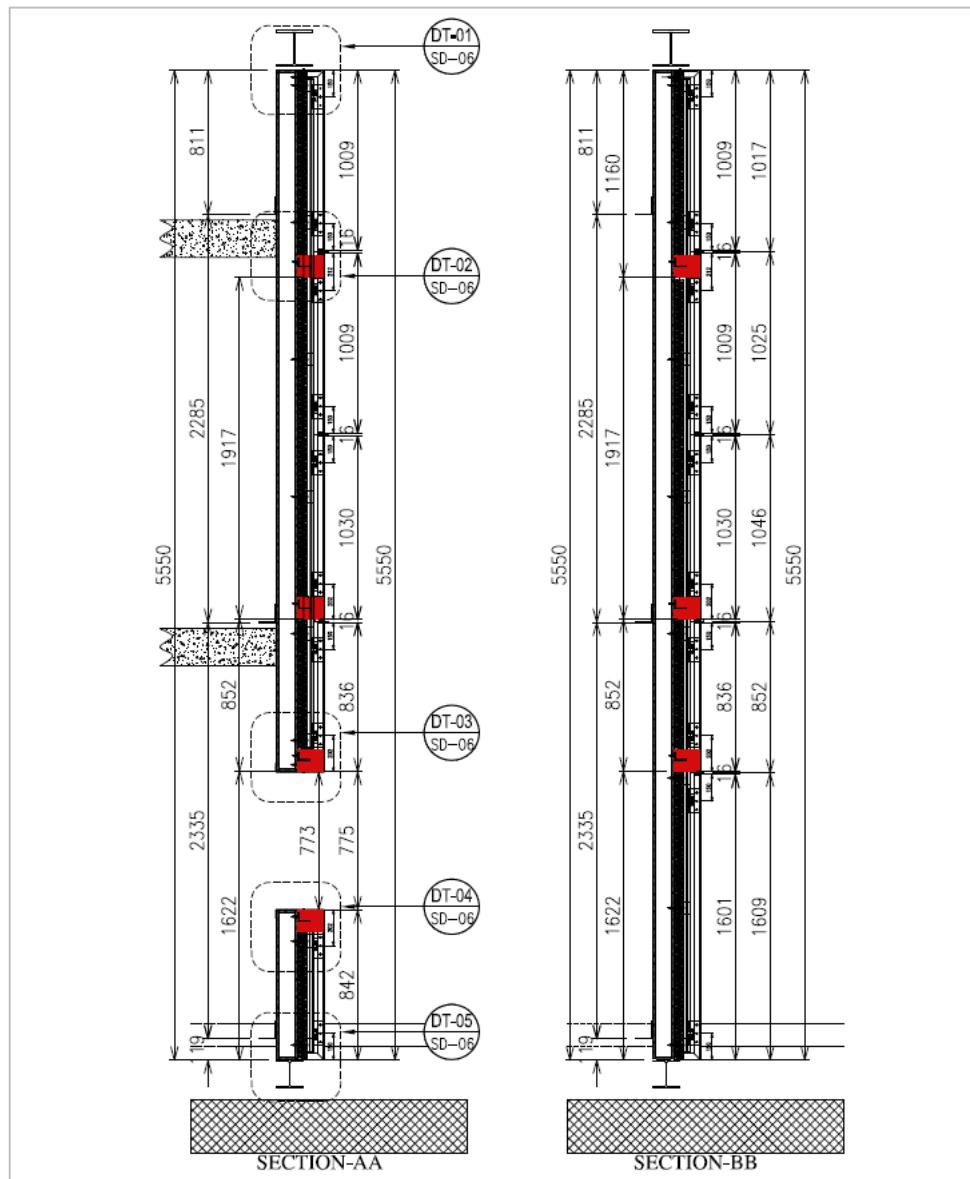
Drawing 8: Vertical sectional views of drawing 5.
(Drawing provided by test sponsor)

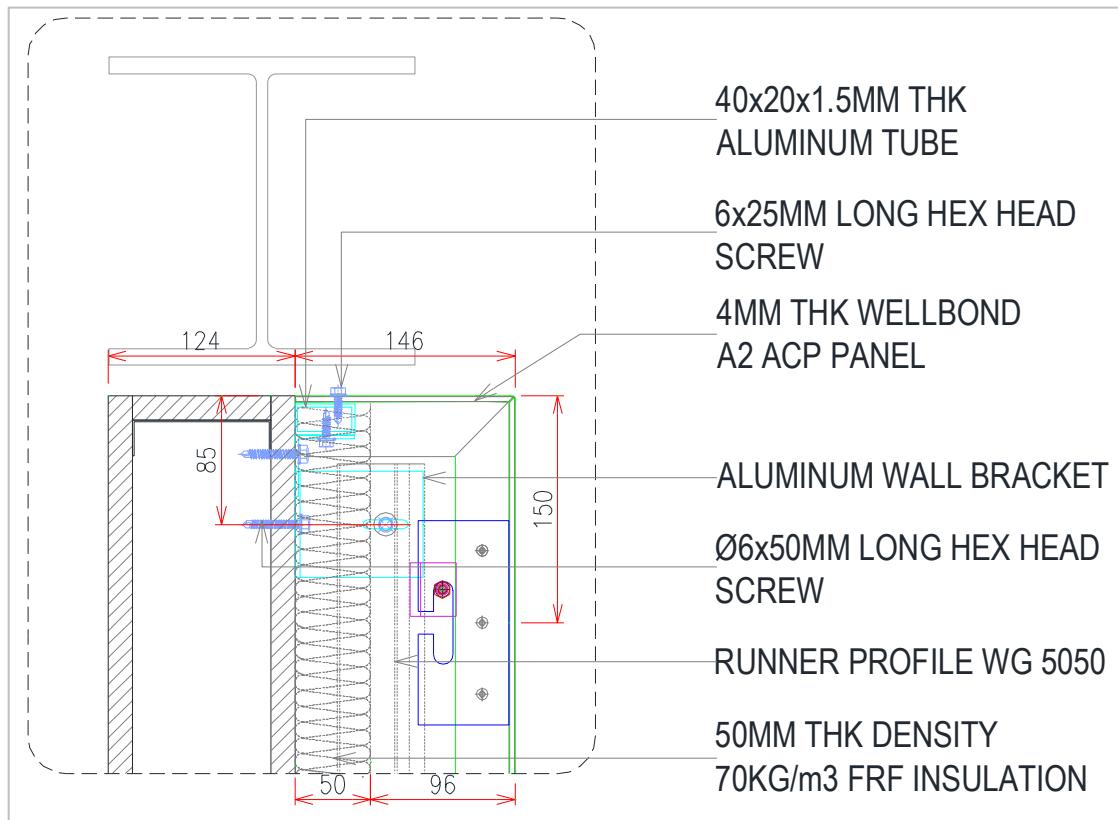
Drawing 9: Detail 01 of drawing 8.
(Drawing provided by test sponsor)

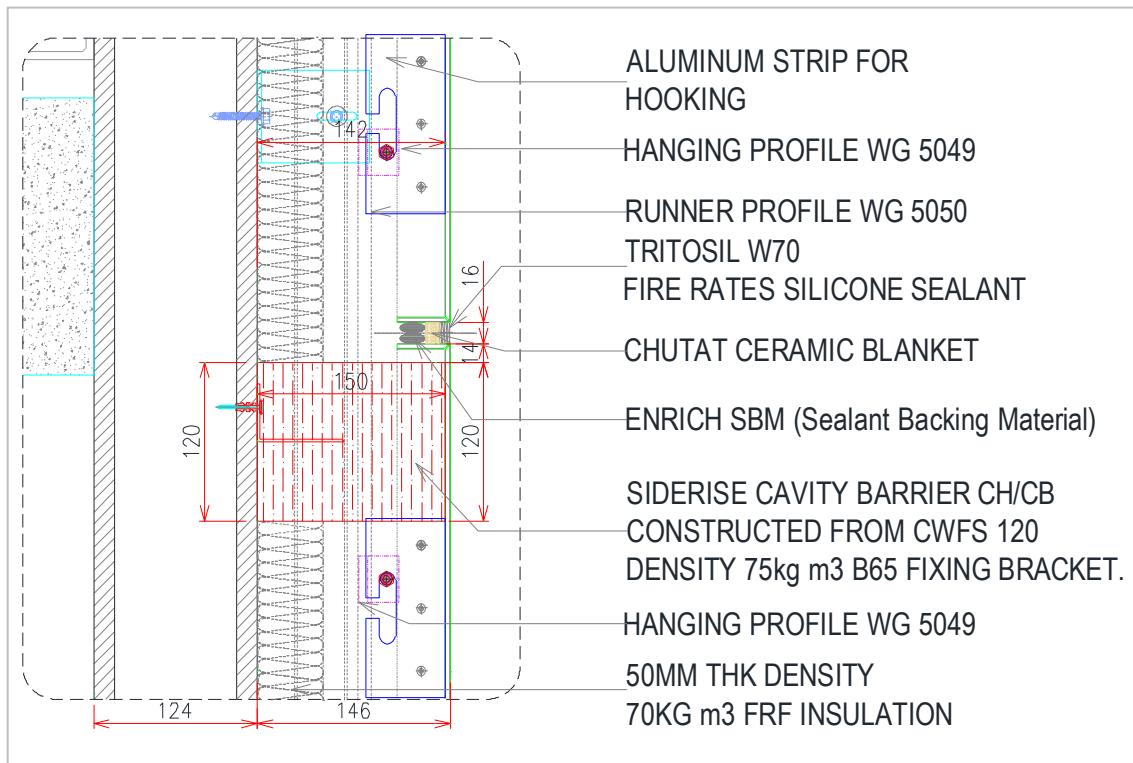
Drawing 10: Detail 02 of drawing 8.
(Drawing provided by test sponsor)

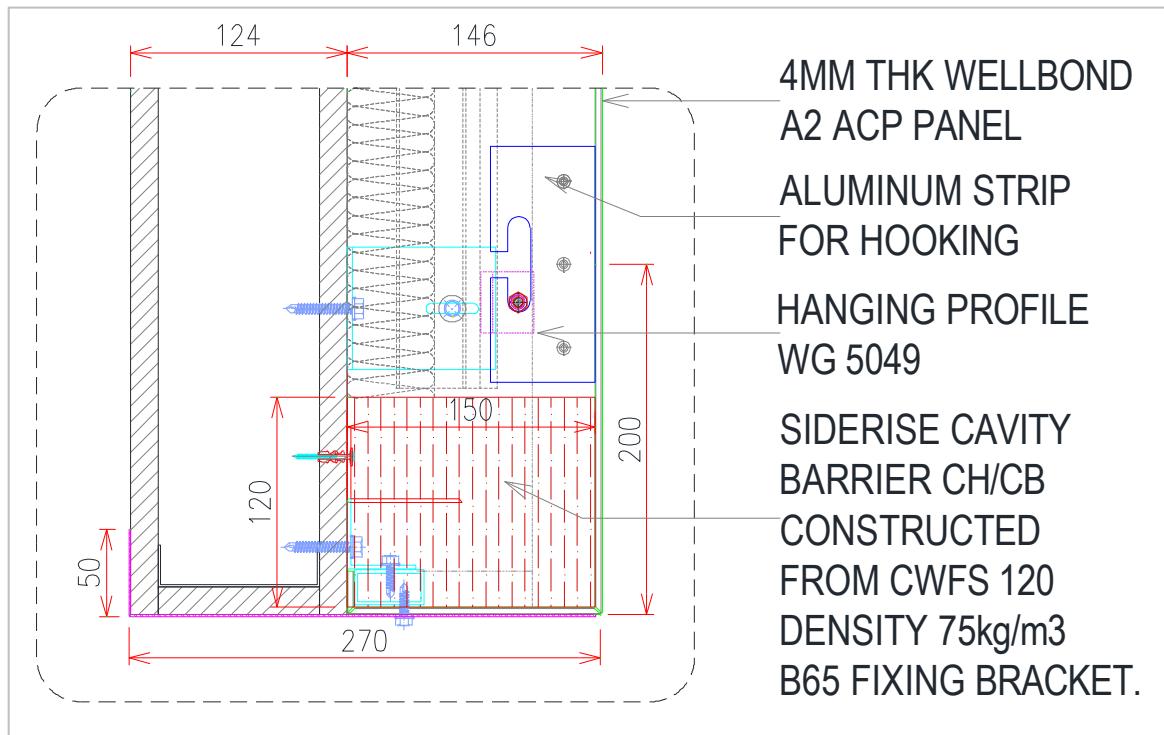
Drawing 11: Detail 03 of drawing 8.
(Drawing provided by test sponsor)

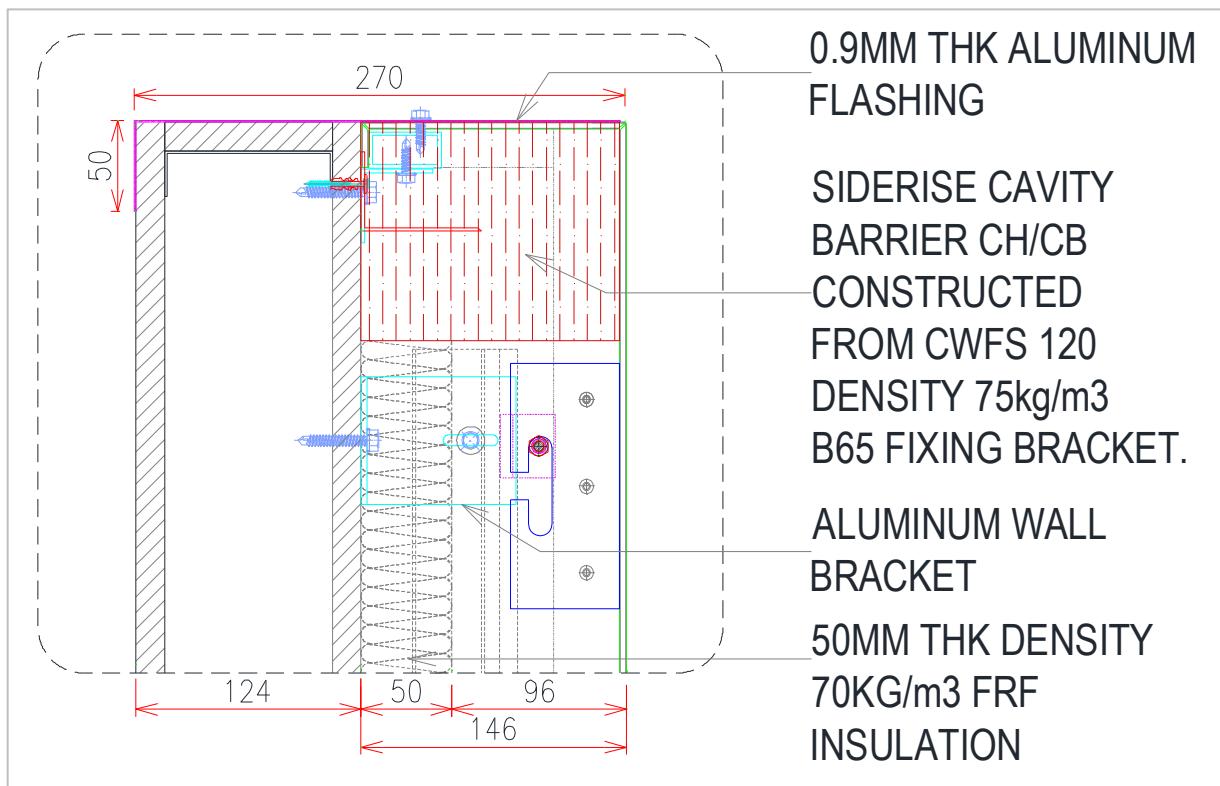
Drawing 12: Detail 04 of drawing 8.
(Drawing provided by test sponsor)

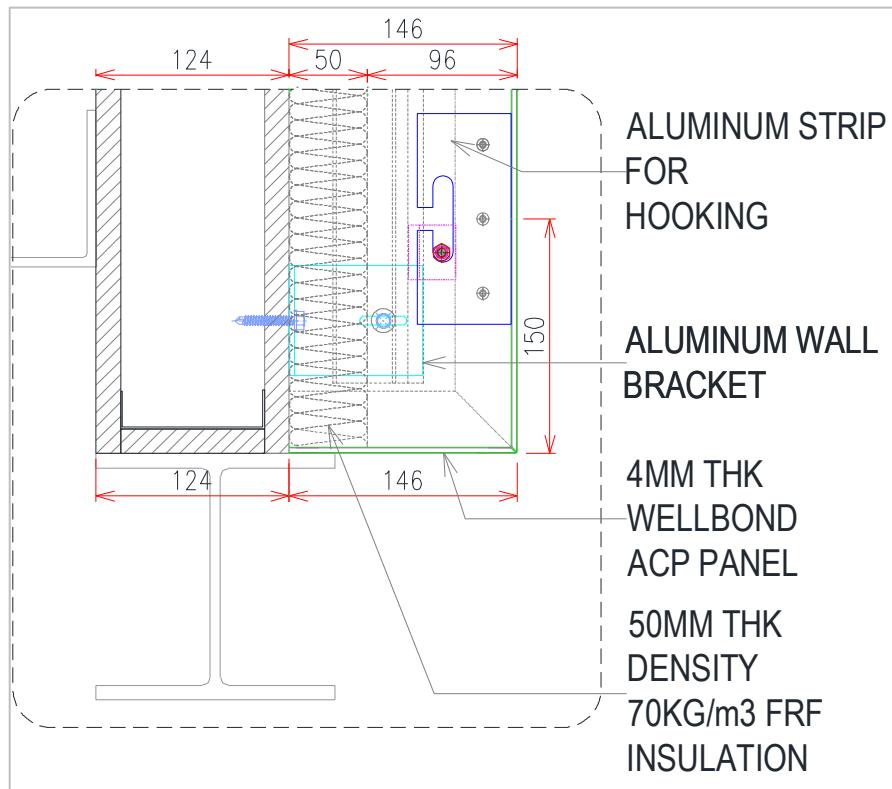
Drawing 13: Detail 05 of drawing 8.
(Drawing provided by test sponsor)

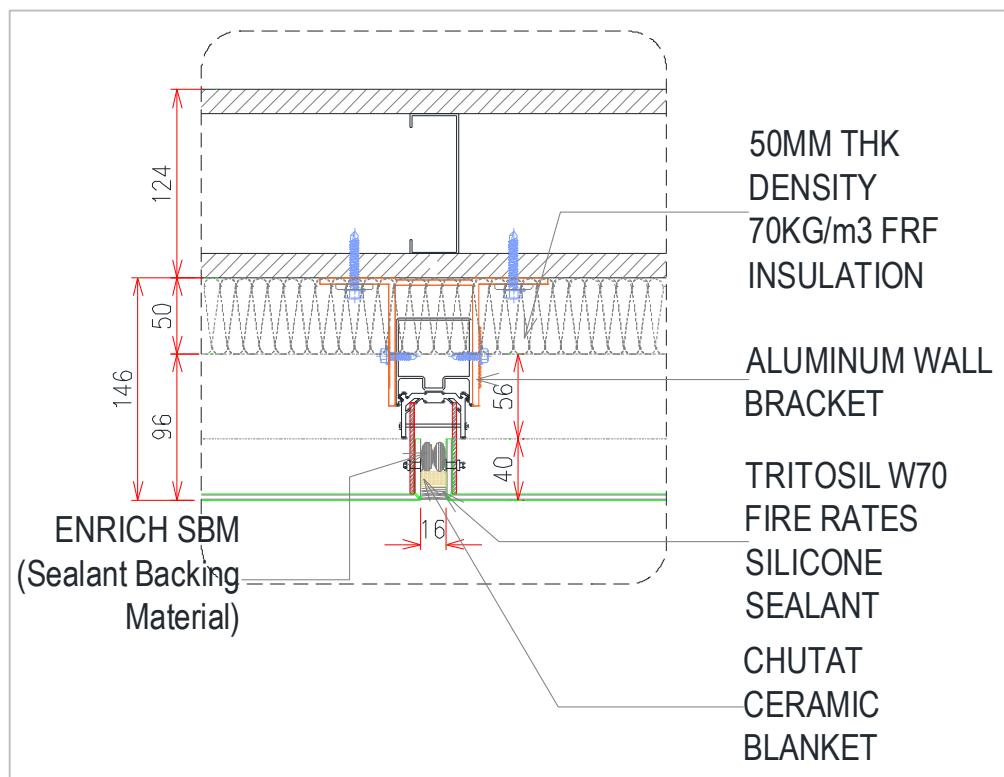
Drawing 14: Detail 06 of drawing 7.
(Drawing provided by test sponsor)

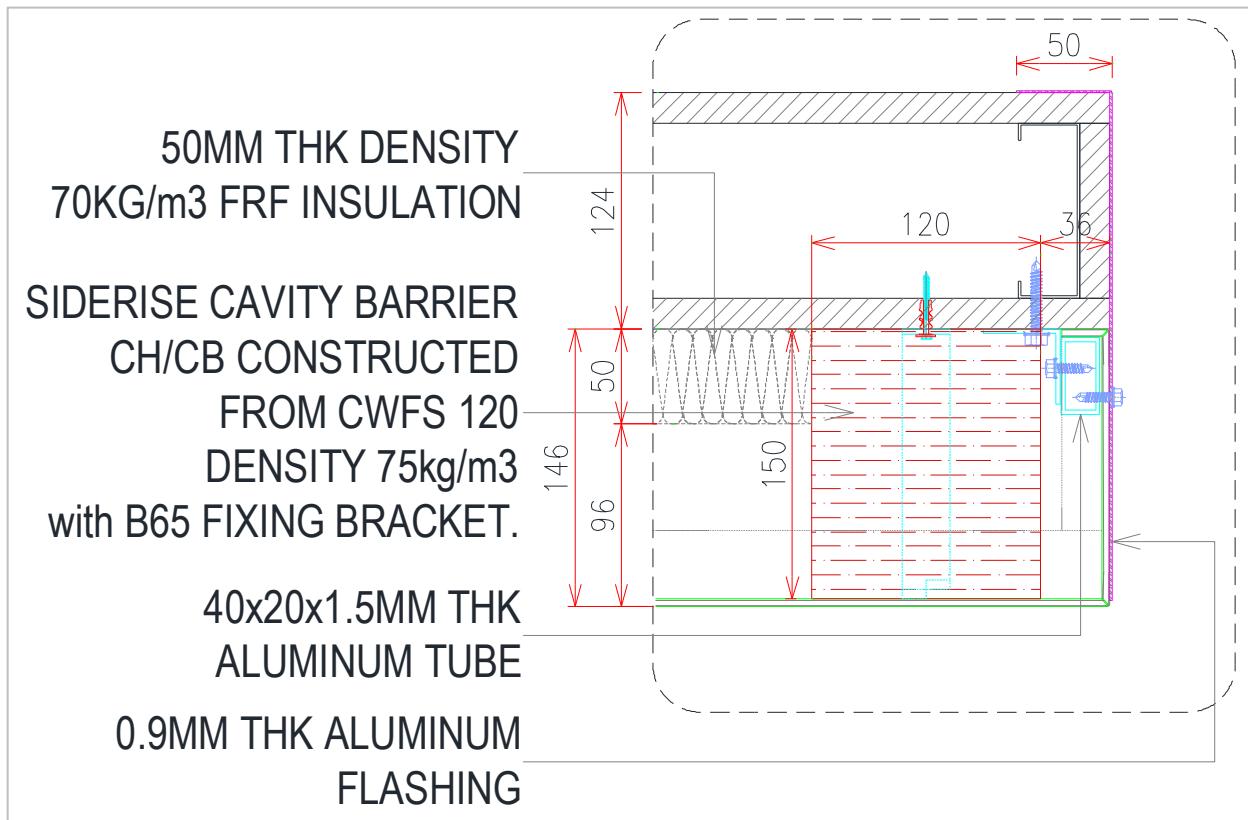
Drawing 15: Detail 07 of drawing 7.
(Drawing provided by test sponsor)

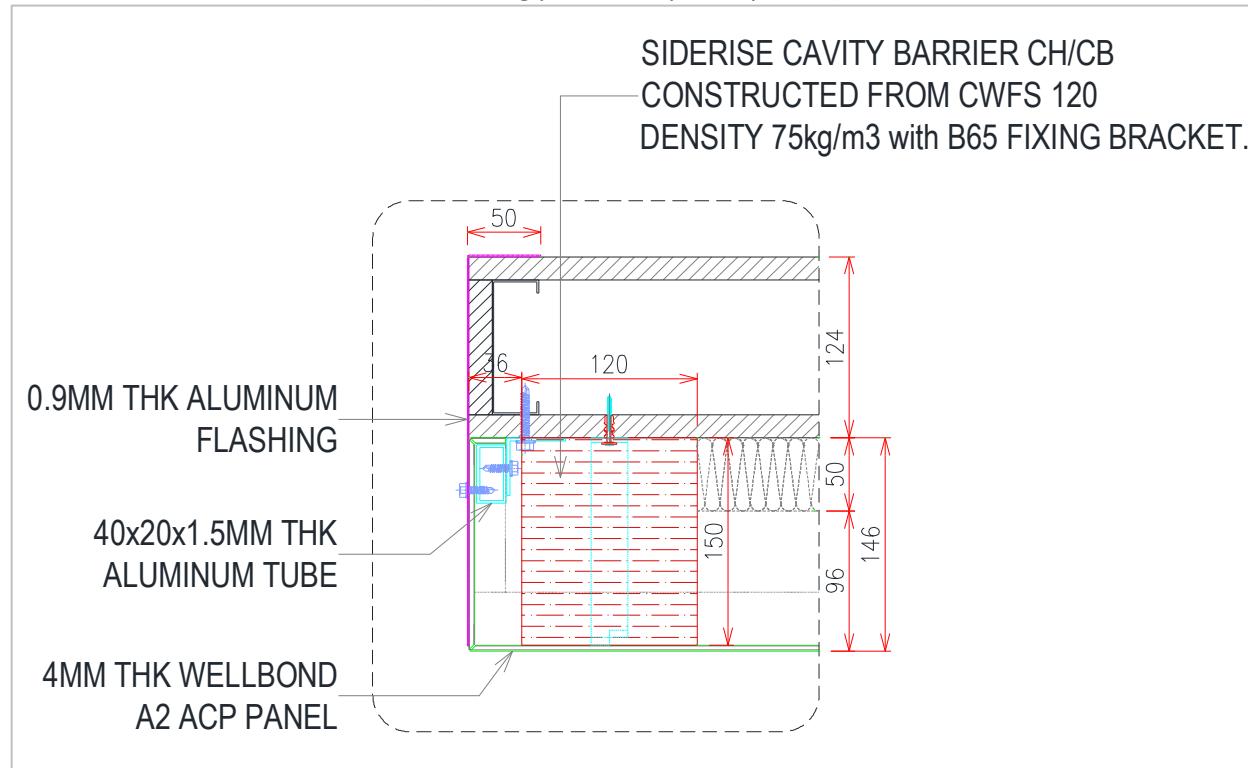
Drawing 16: Detail 08 of drawing 7.
(Drawing provided by test sponsor)

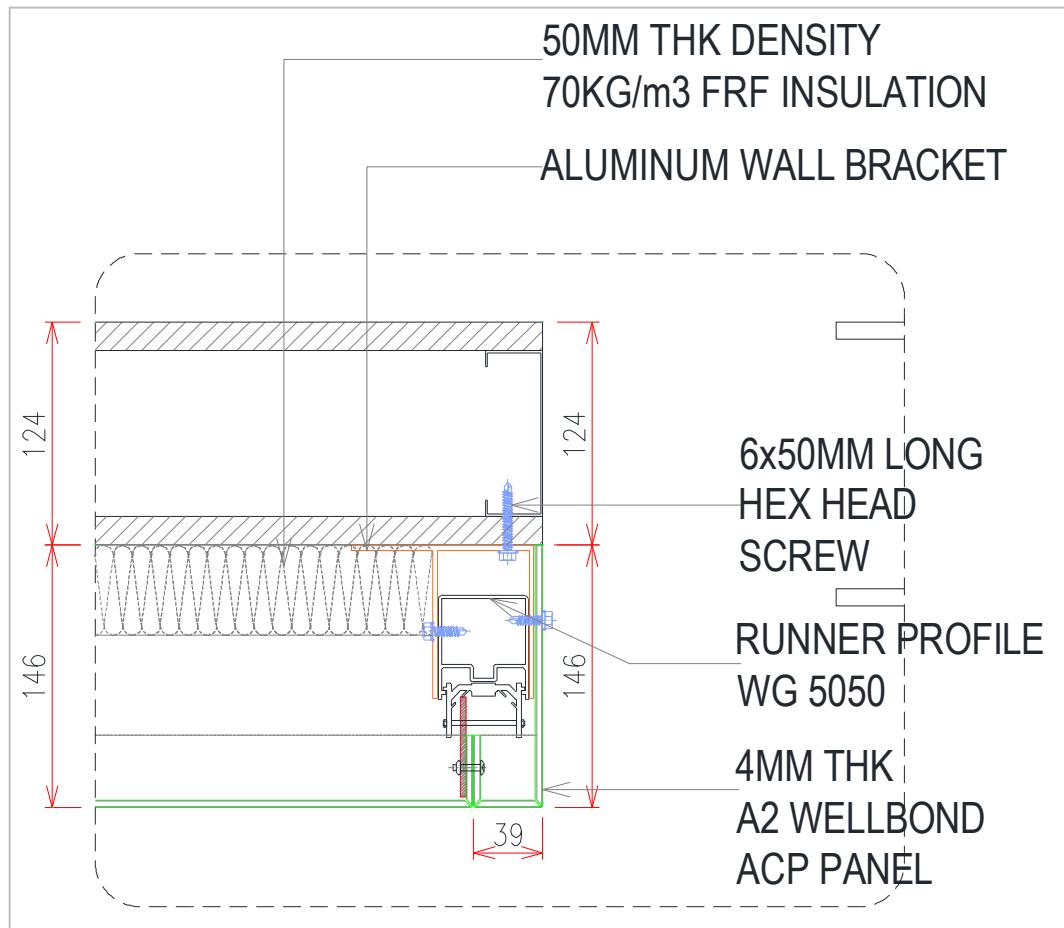
Drawing 17: Detail 09 of drawing 7.
(Drawing provided by test sponsor)
