TEST REPORT FOR FIRE PROPAGATION CHARACTERISTICS OF EXTERIOR WALL ASSEMBLIES

4mm thick WELLBOND-A2 Aluminium Composite Panel (ACP) Cladding Assembly.

NFPA 285: Standard Fire Test Method for Evaluation of Fire Propagation Characteristics of Exterior Wall Assemblies Containing Combustible Components, 2019 Edition.

Test Reference No: WC157-1

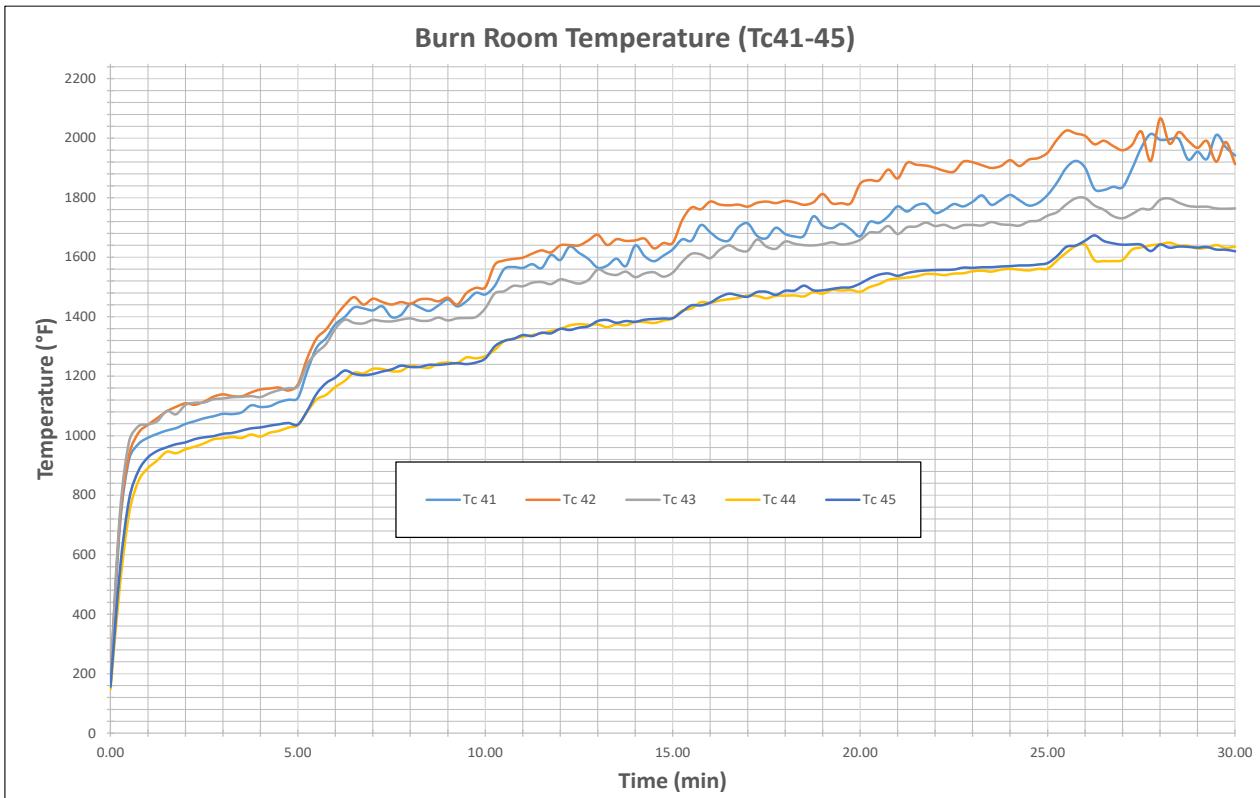
Graph 1: Burn room thermocouple temperature (Tc41 – Tc45)

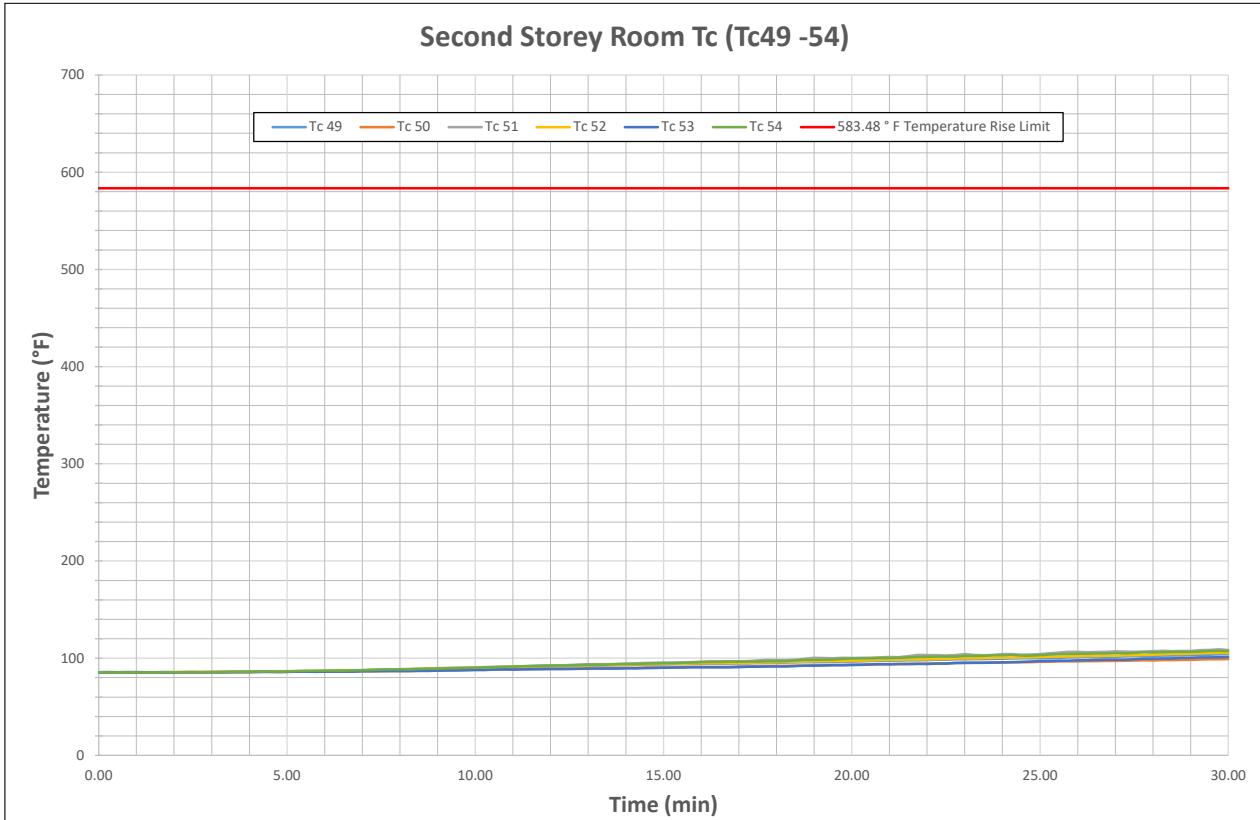
Graph 2: Second story room thermocouple temperatures (Tc49-Tc54)

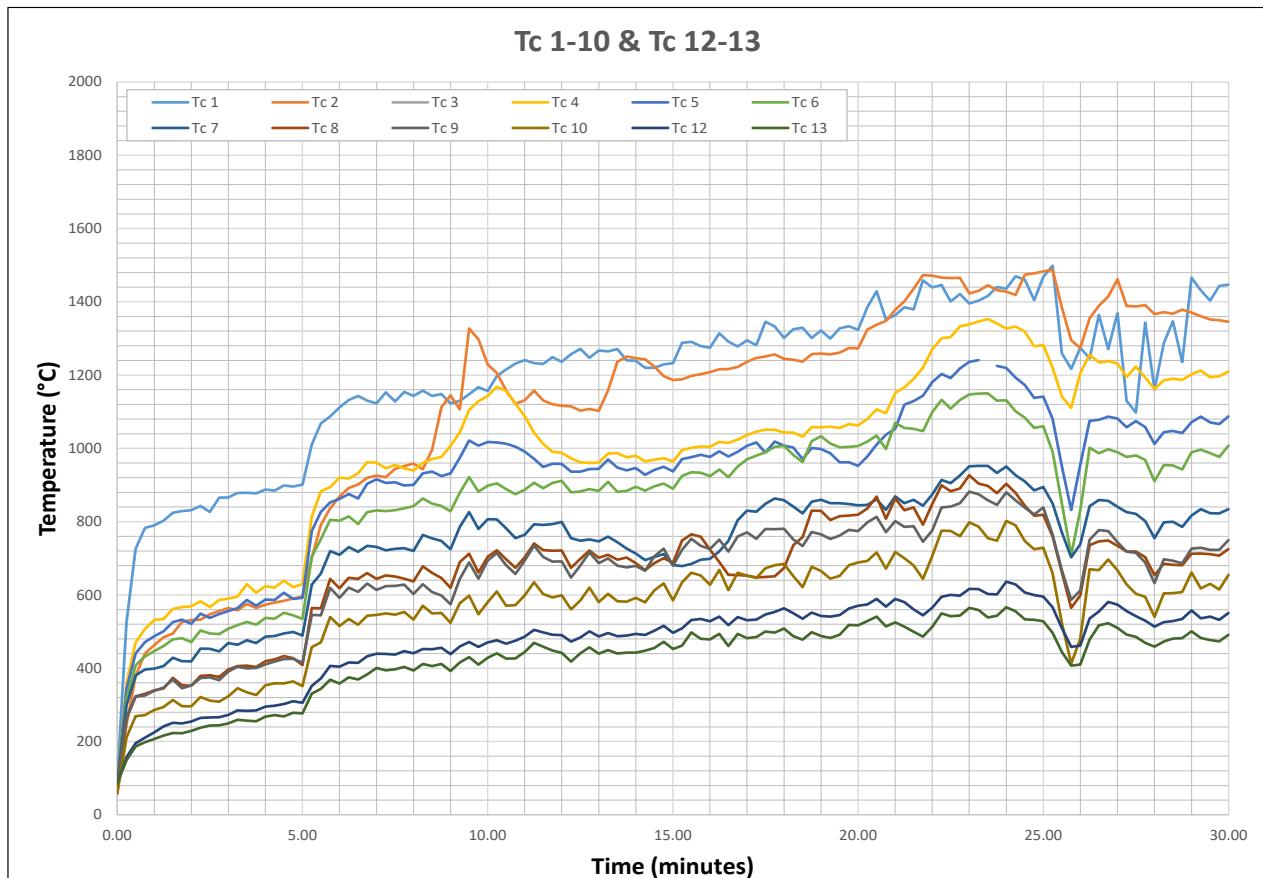
Graph 3: Thermocouple temperatures for Tc1 -Tc10 and Tc12 – Tc23.

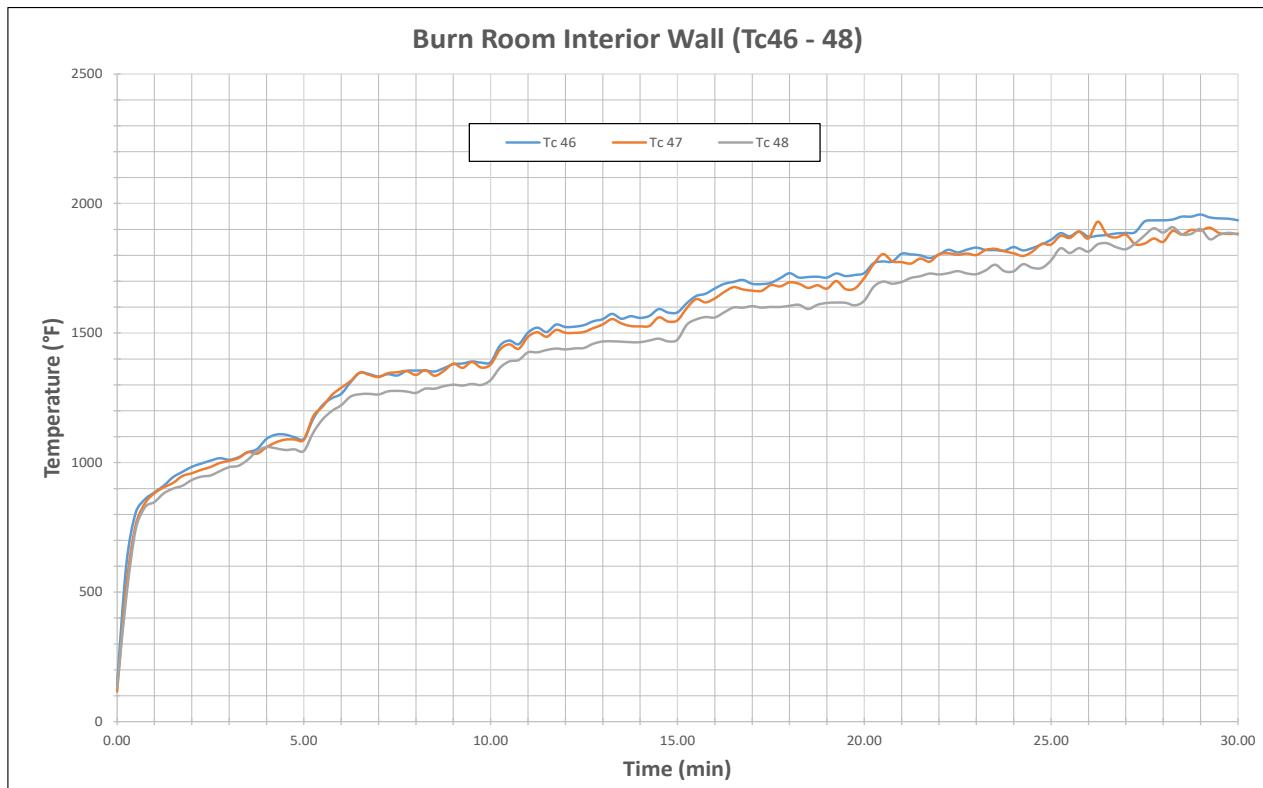
Graph 4: Burn room interior wall temperature (Tc46 – Tc48)

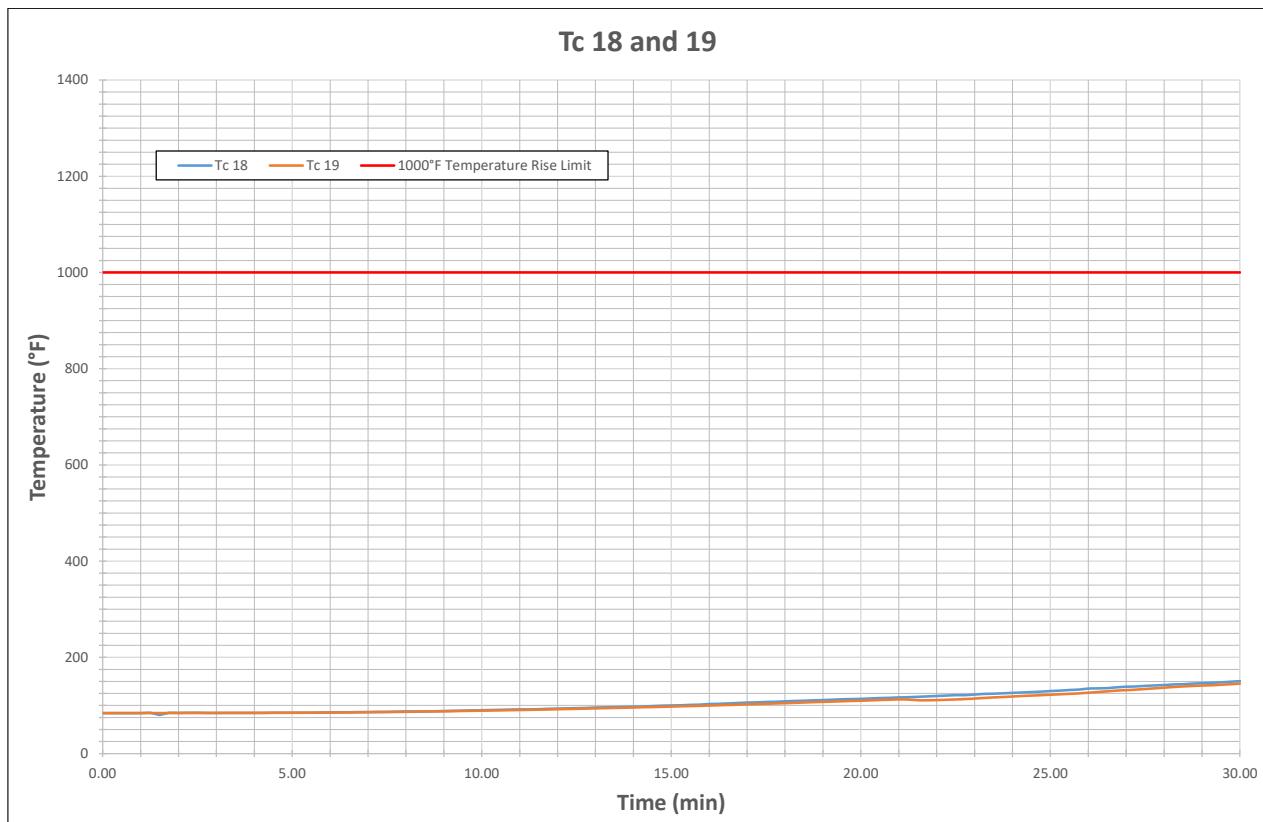
Graph 6: Thermocouple temperatures for Tc18 and Tc19.

Temperatures in the wall cavity air space shall not exceed 1000°F as measured by thermocouples Tc-18 and Tc-19.	Tc-18 and Tc-19 did not exceed the 1000°F limit.	Pass
Temperatures in the wall cavity air space shall not exceed 1000°F as measured by thermocouples Tc-28 and Tc-31 through 40.	Tc-28 and Tc-31 through Tc-40 did not exceed the 1000°F limit.	Pass
Temperatures measured 1 in. (25mm) from the interior surface of the test specimen within the second story test room shall not exceed 500 °F above ambient air temperature of test facility at the start of fire test as measured by Tc-49 through Tc-54.	Tc-49 through Tc-54 did not exceed the maximum temperature of 583.5°F. (500°F + Initial Ambient Temperature = 500°F + 83.5°F = 583.5°F).	Pass

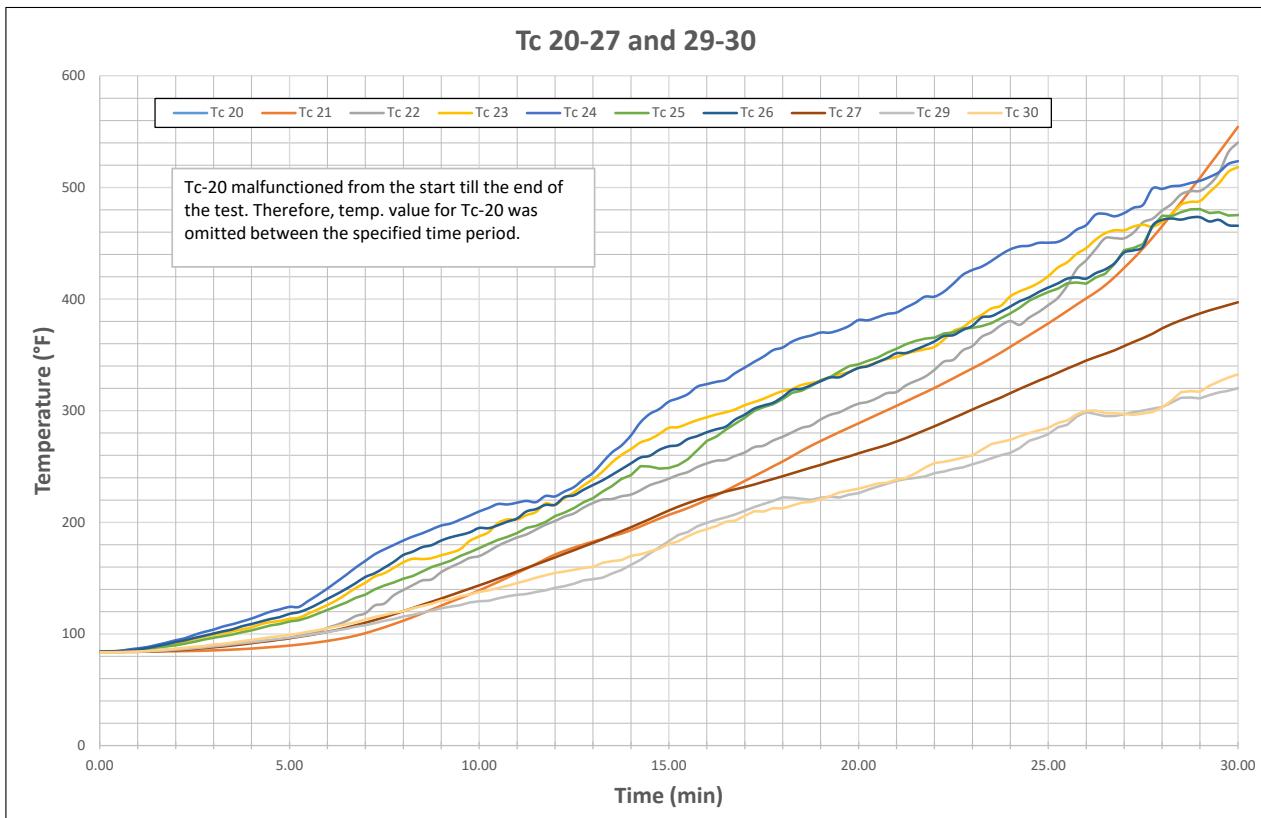
Graph 7: Thermocouple temperatures for Tc20 – Tc27 and Tc29 – Tc30.

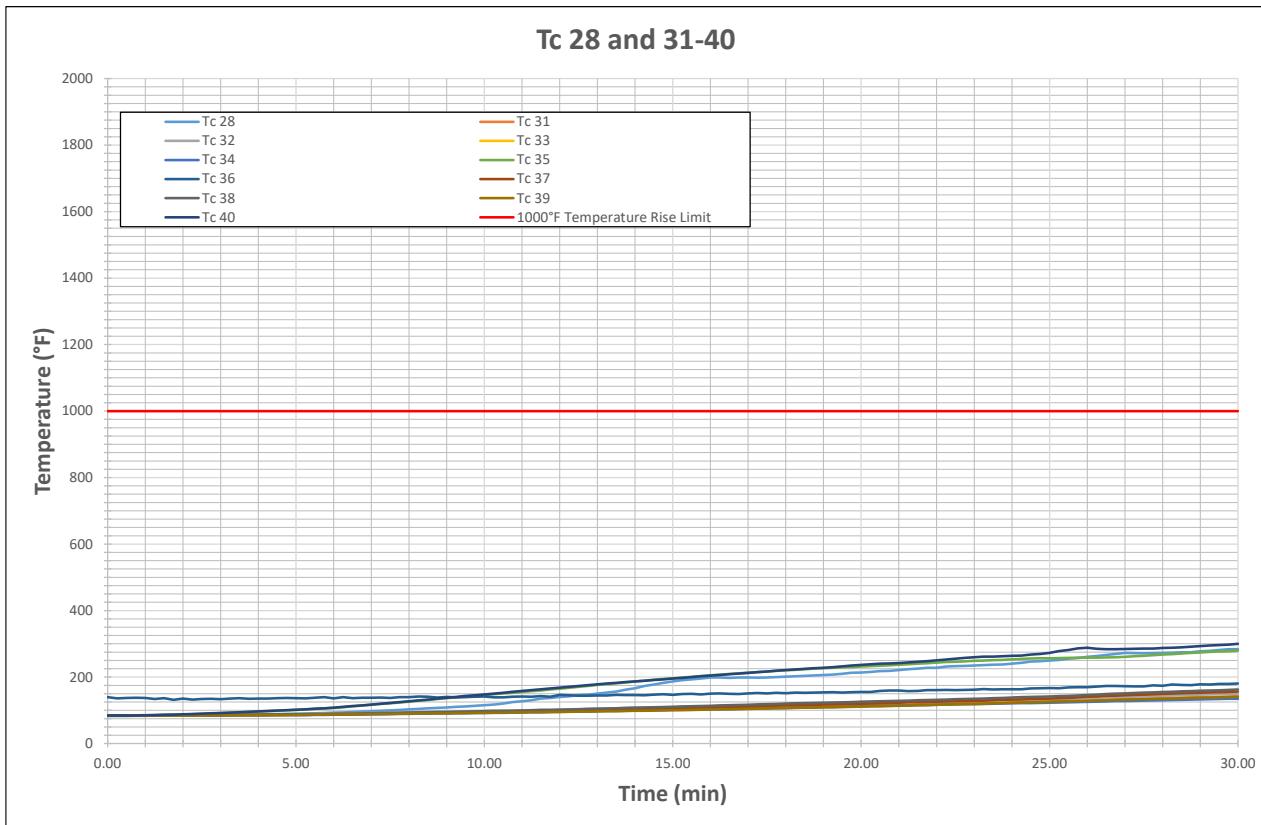
Graph 8: Thermocouple temperatures for Tc28 and Tc31 – Tc40.

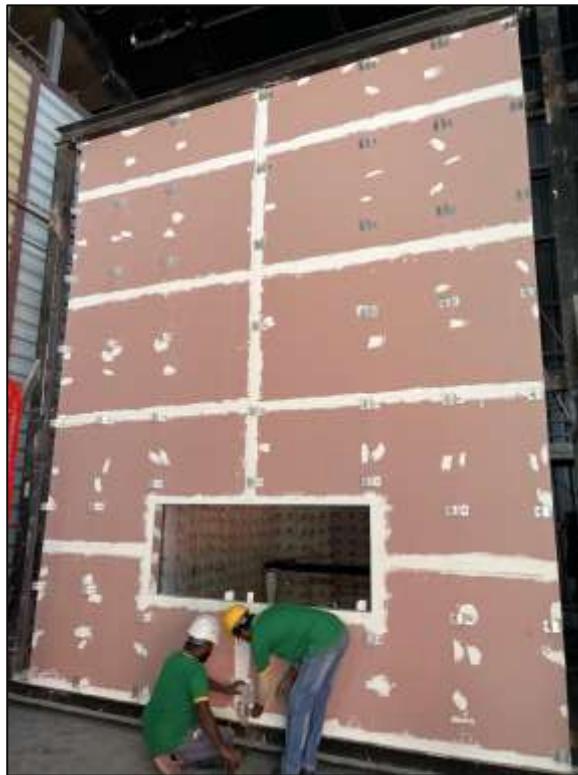
Picture 1: View of the wall brackets fixed onto the base wall.

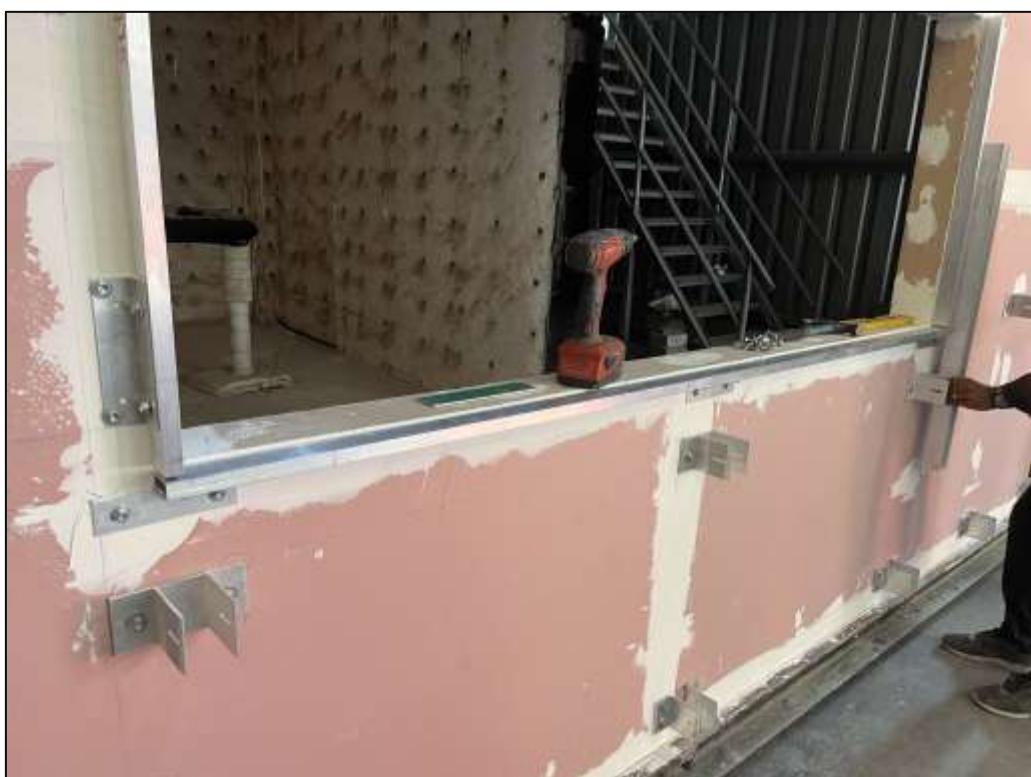
Picture 2: View of the steel tube channels fixed along the perimeter edge of the window opening.

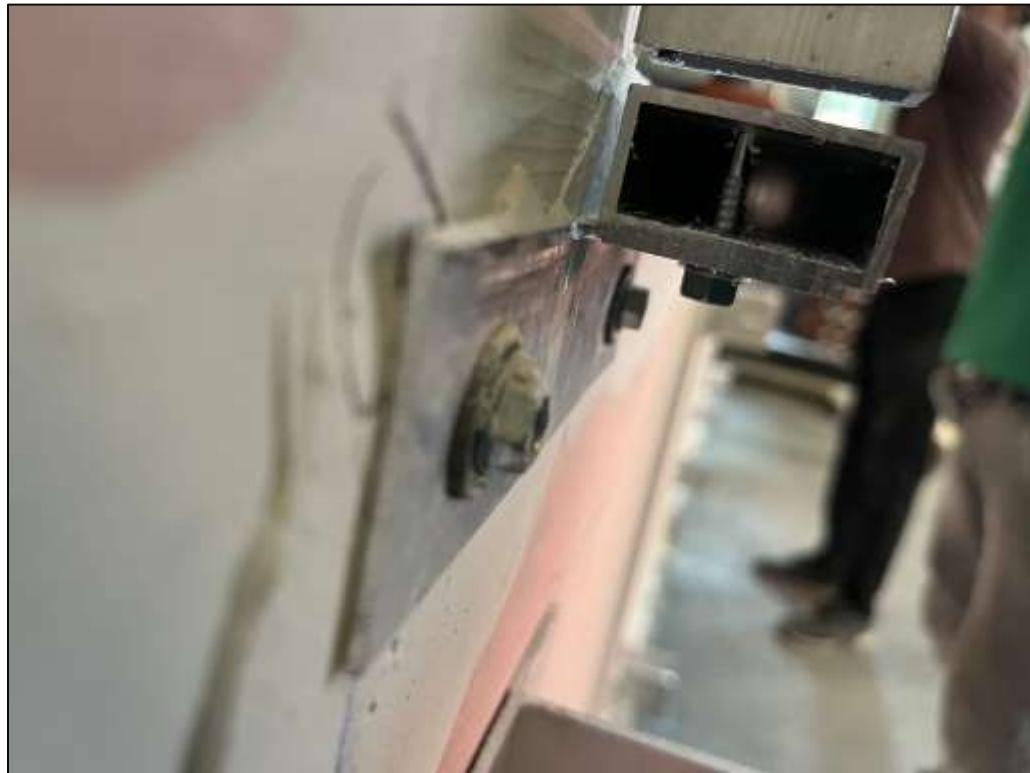
Picture 3: A close-up side view of the window perimeter tube channel.

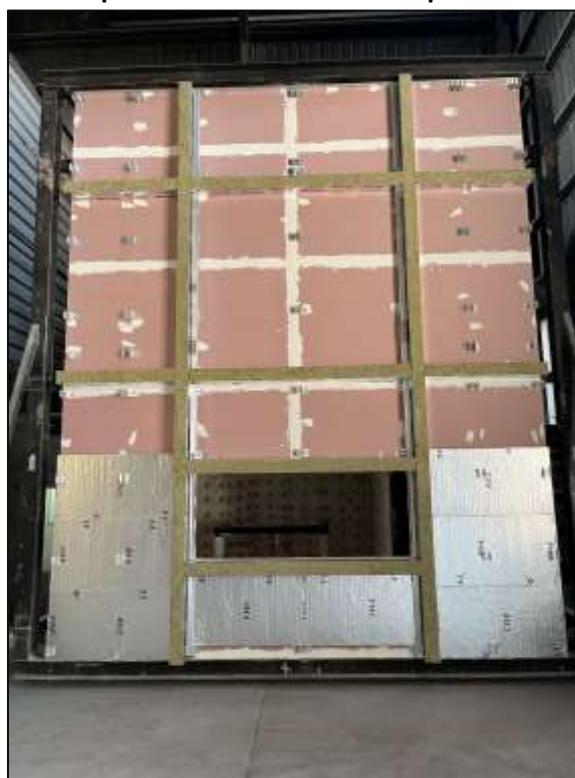
Picture 4: View of the completion of the cavity fire barriers and start of the exterior insulation.

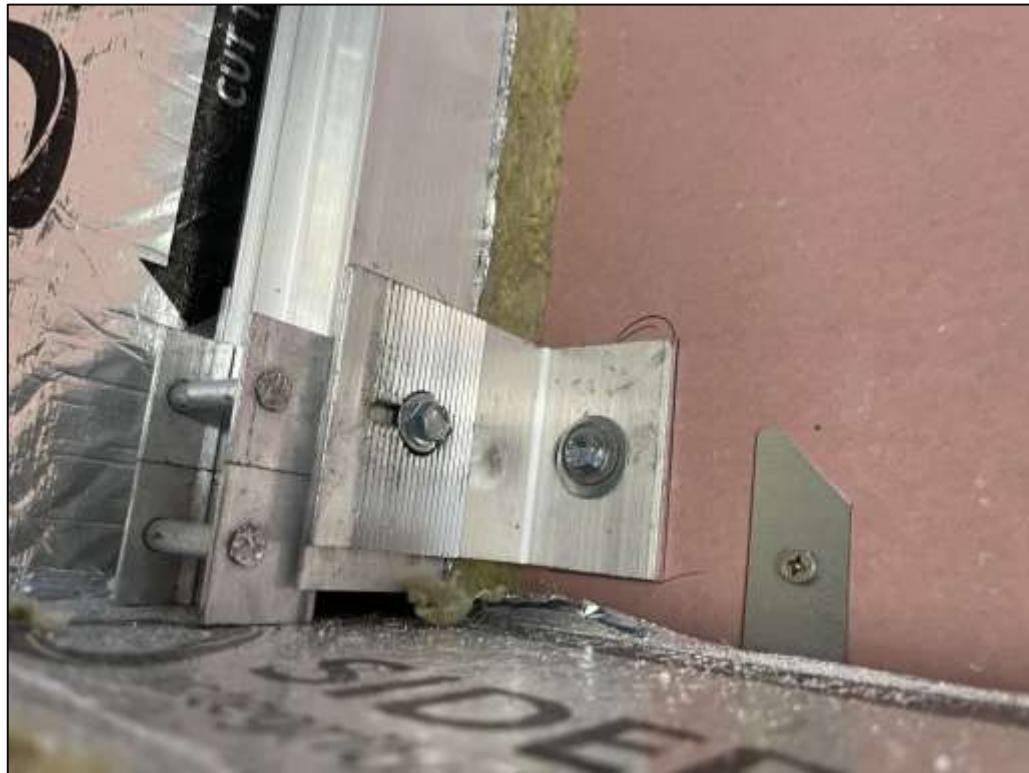
Picture 5: View of the runner to wall bracket fixing method.

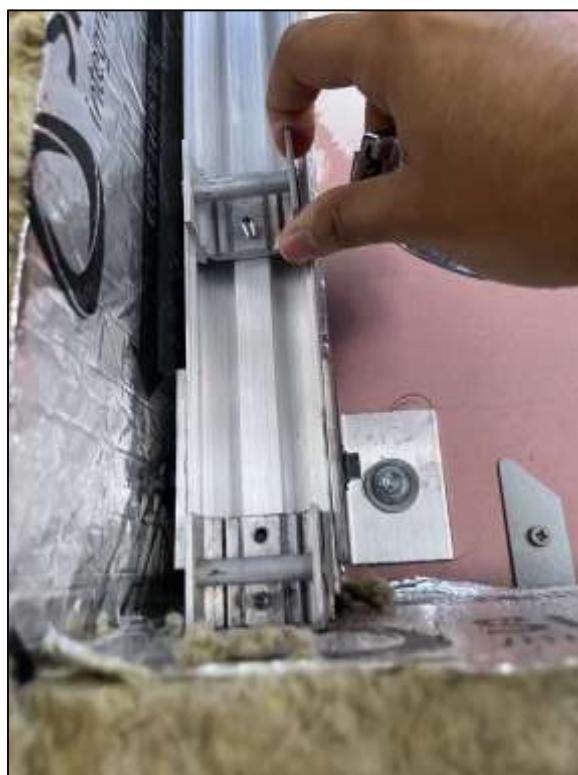
Picture 6: Panel holding clamps supported onto the runners.

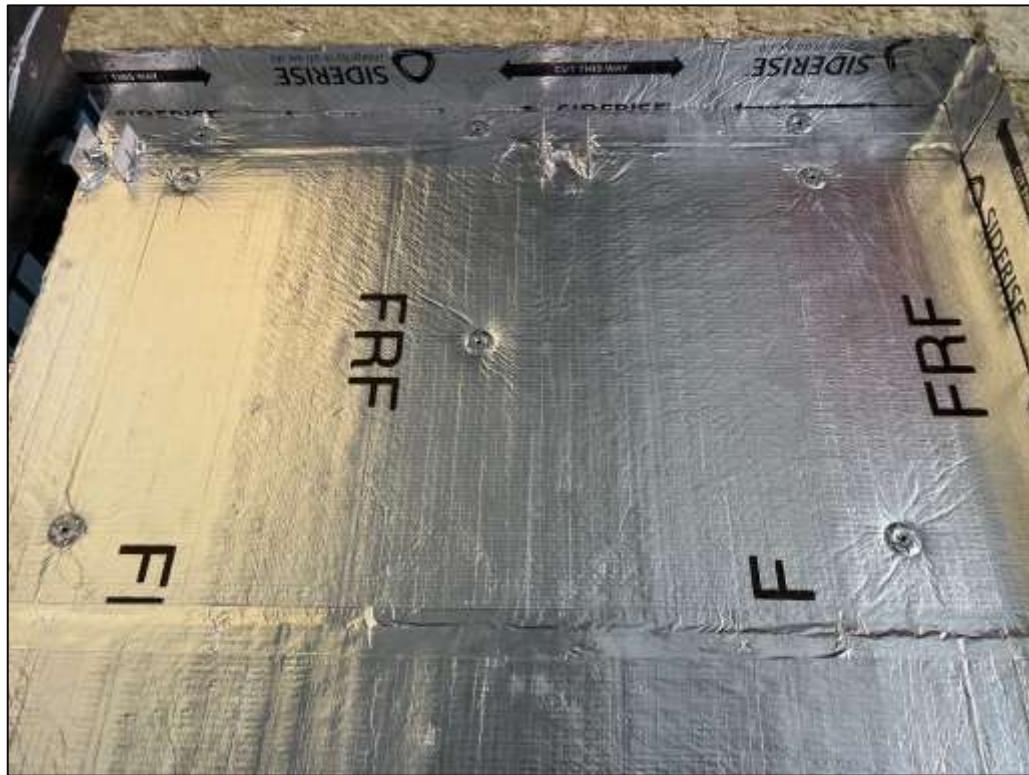
Picture 7: View of the method of fixing the exterior insulation slabs in place.

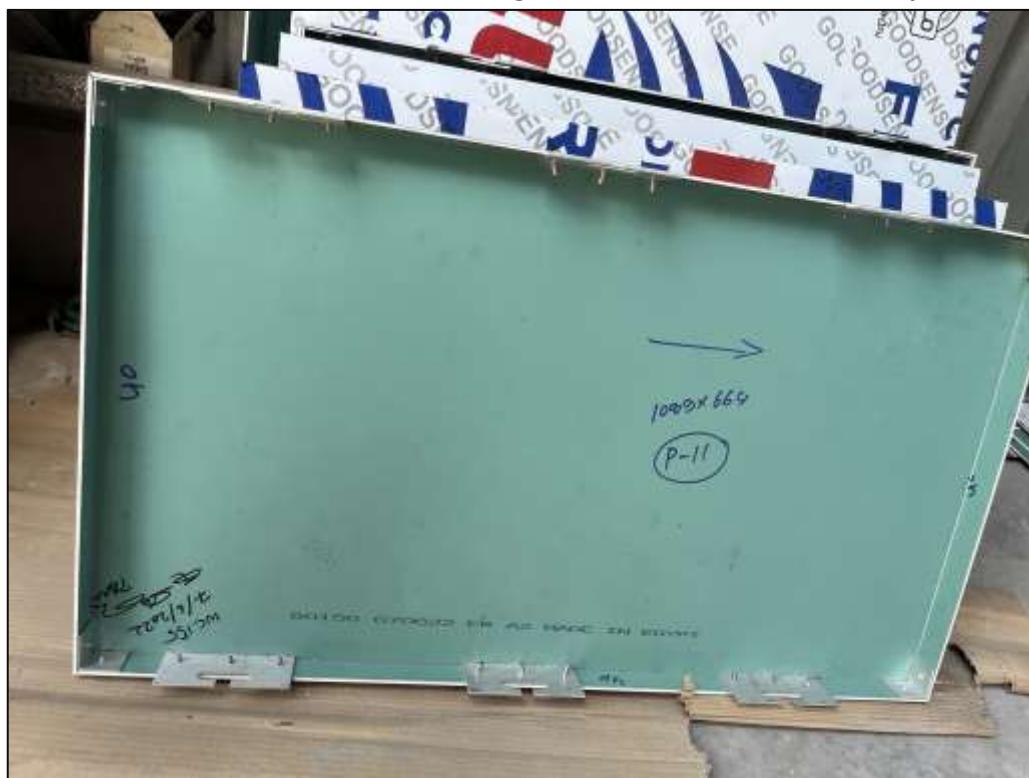
Picture 8: A typical view of the backside of the panel.

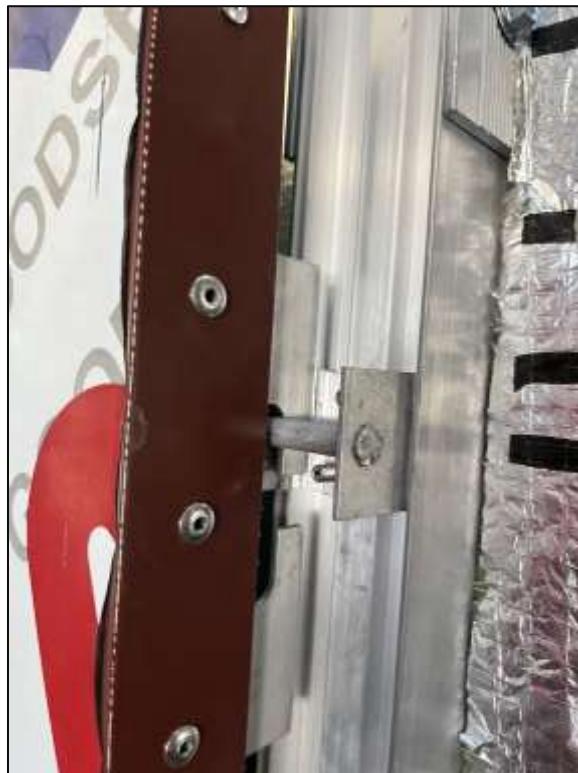
Picture 9: Method of fixing the panel in place with the support of panel clamps.

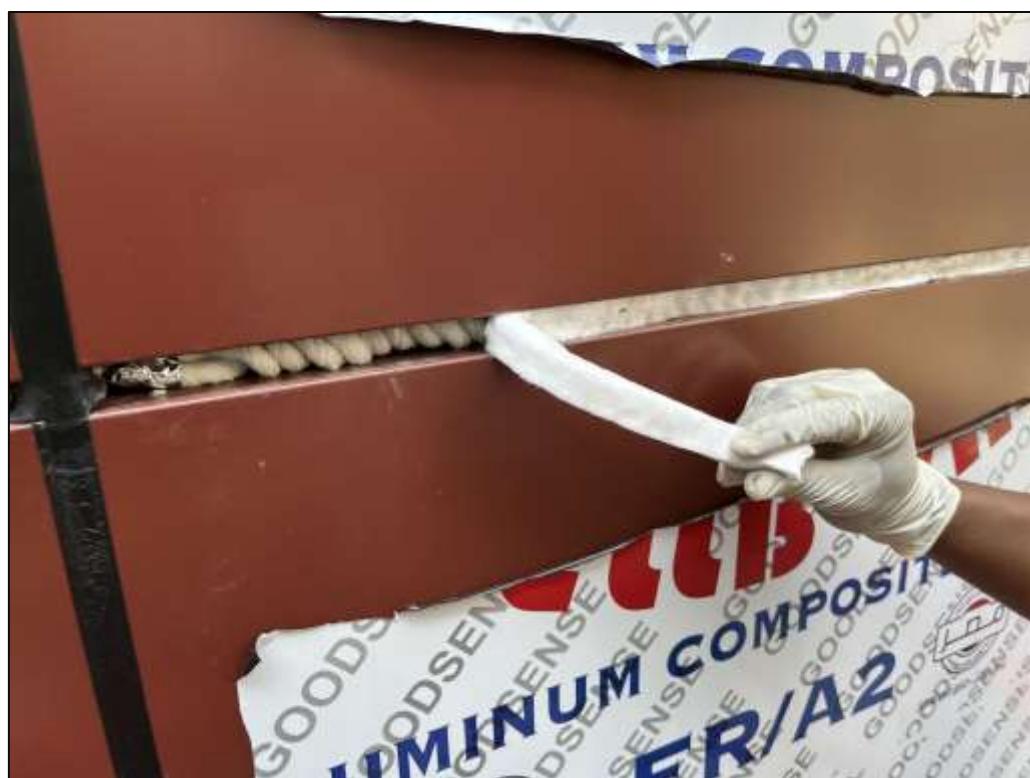
Picture 10: Ceramic piece being inserted into the panel joints after fixing the spiral threaded backers.

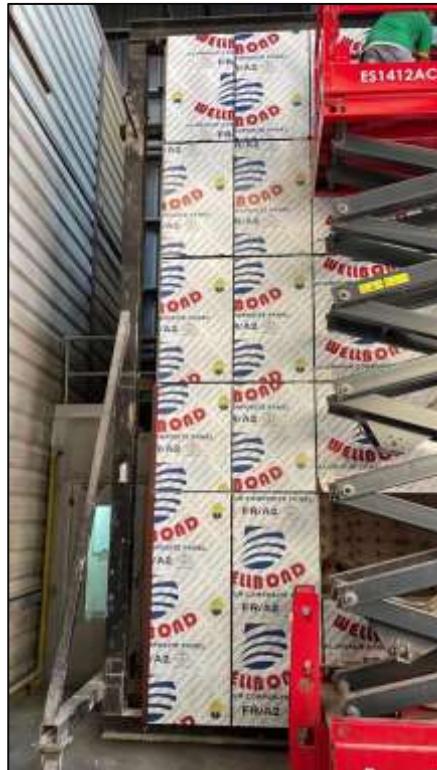
Picture 11: View of installing the cladding panels.

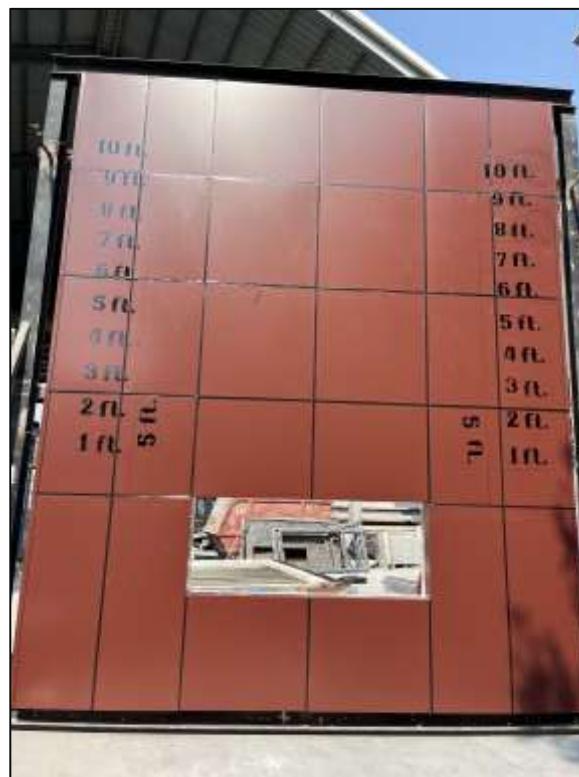
Picture 12: Completed view of the installation.

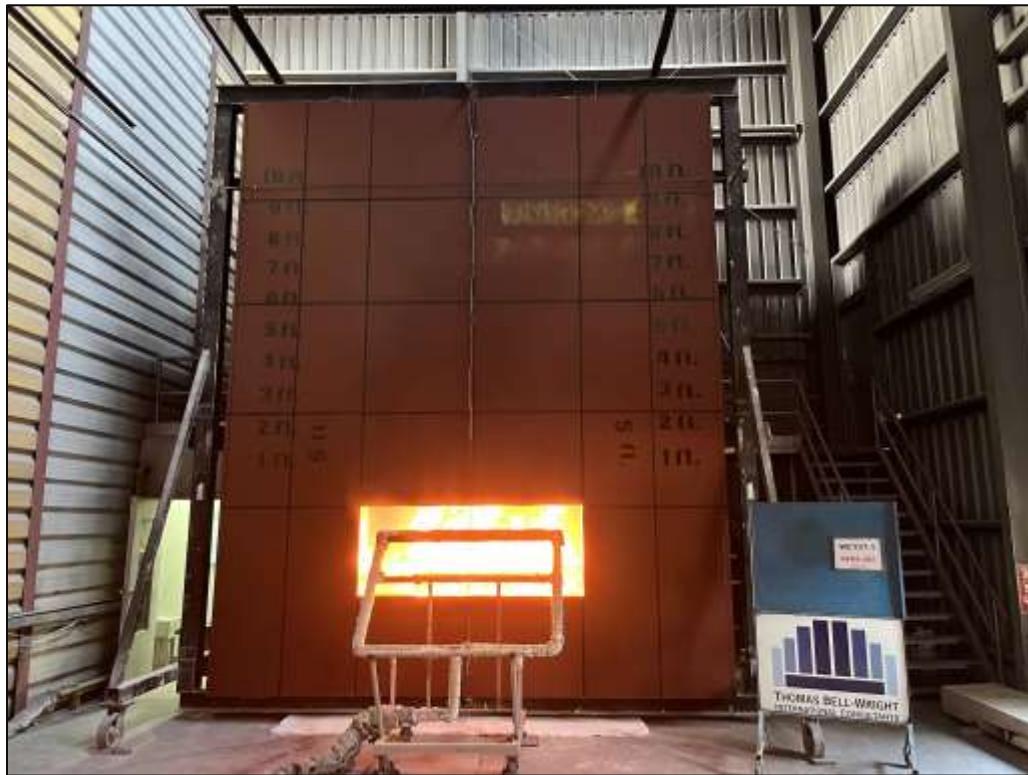
Picture 13: The specimen at the beginning of the test.

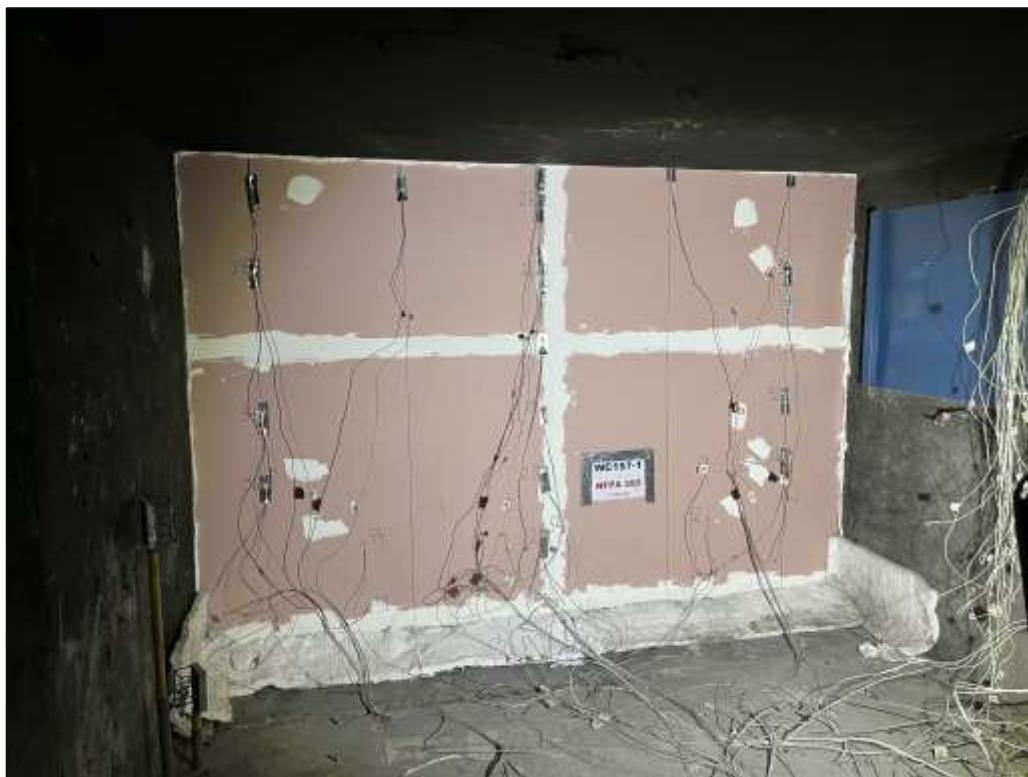
Picture 14: The interior of the base wall in the second-floor test room at the beginning of the test.

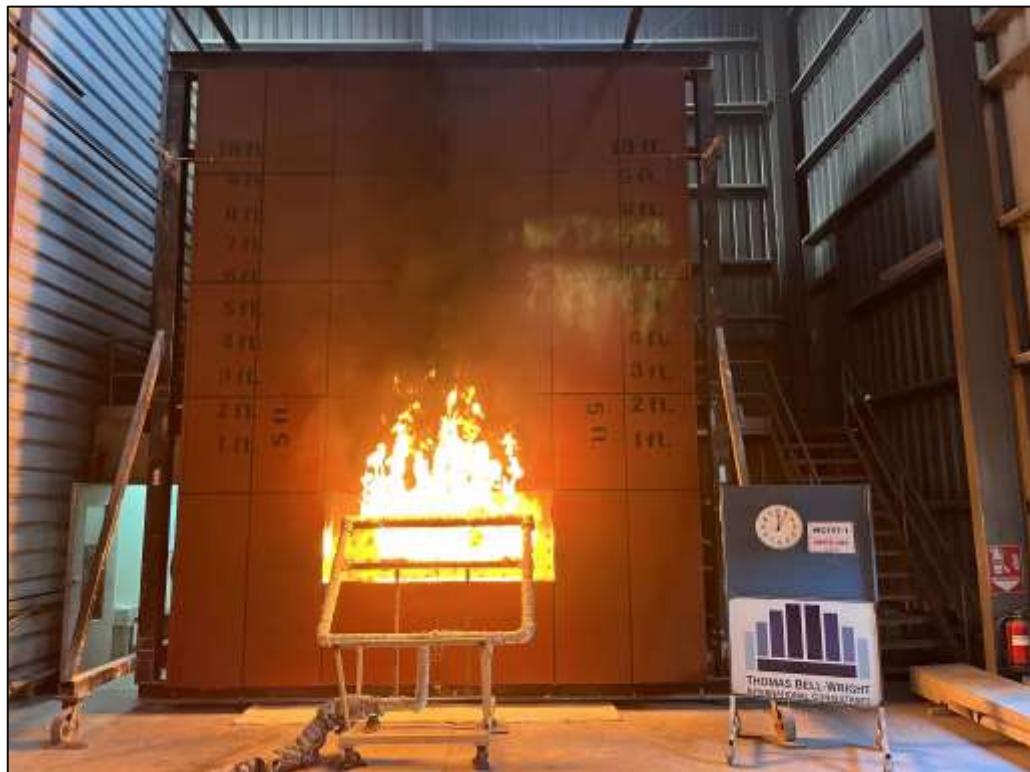
Picture 15: The specimen at 5:00 minutes and when the window burner was ignited.

5:00	The window burner was ignited.
6:25	Coating on the panel 07R was observed peeling off till 2 feet.
7:00	Flashing along the window head and jambs was observed deforming.

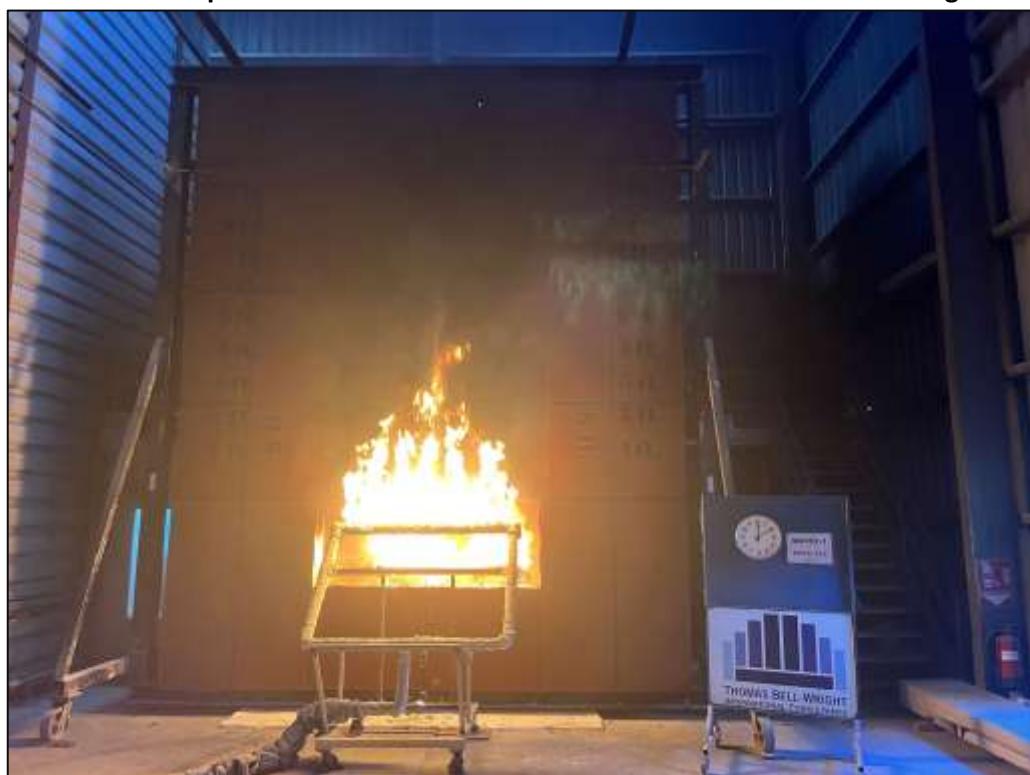
Picture 16: The specimen at 10:00 minutes.

10:00	The specimen was stable.
10:15	Coating on the panels were observed peeling off till 3 feet near to the bottom surface of panel 04R.
10:20	Flame debris was observed falling on the test room floor.

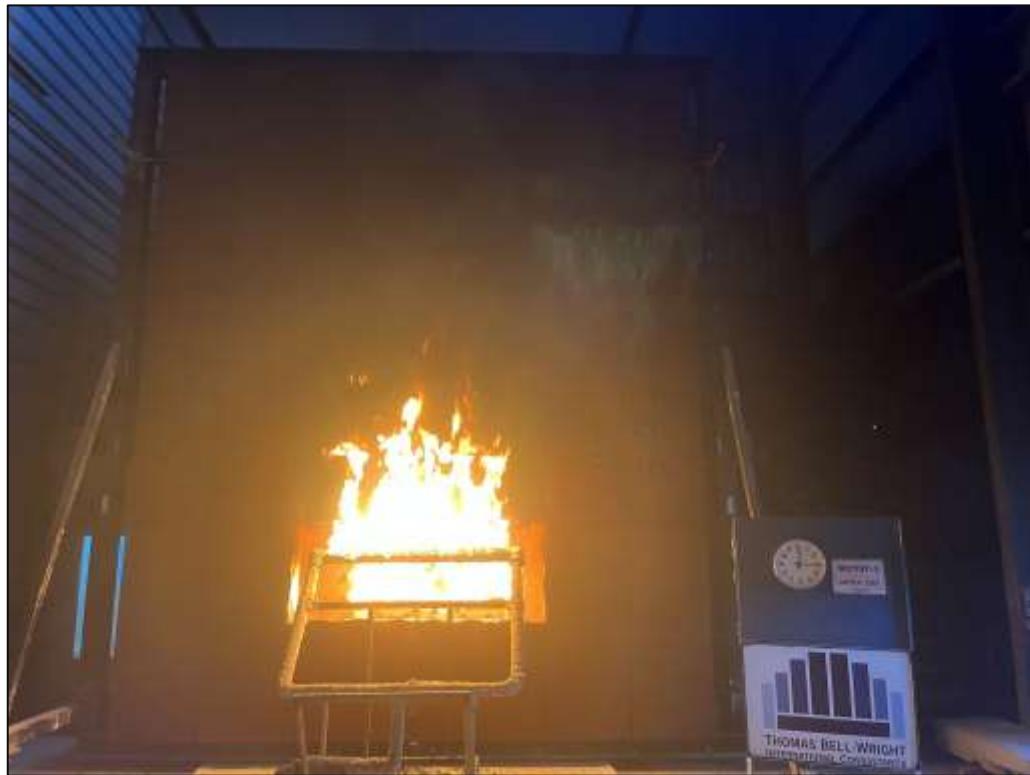
Picture 17: The specimen at 15:00 minutes.

15:00	The specimen was stable.
15:40	Coating on the panels were observed peeling off till 3.5 feet.
20:00	The specimen was stable.
20:30	Coating on the panels were observed peeling off till 4.5 feet.

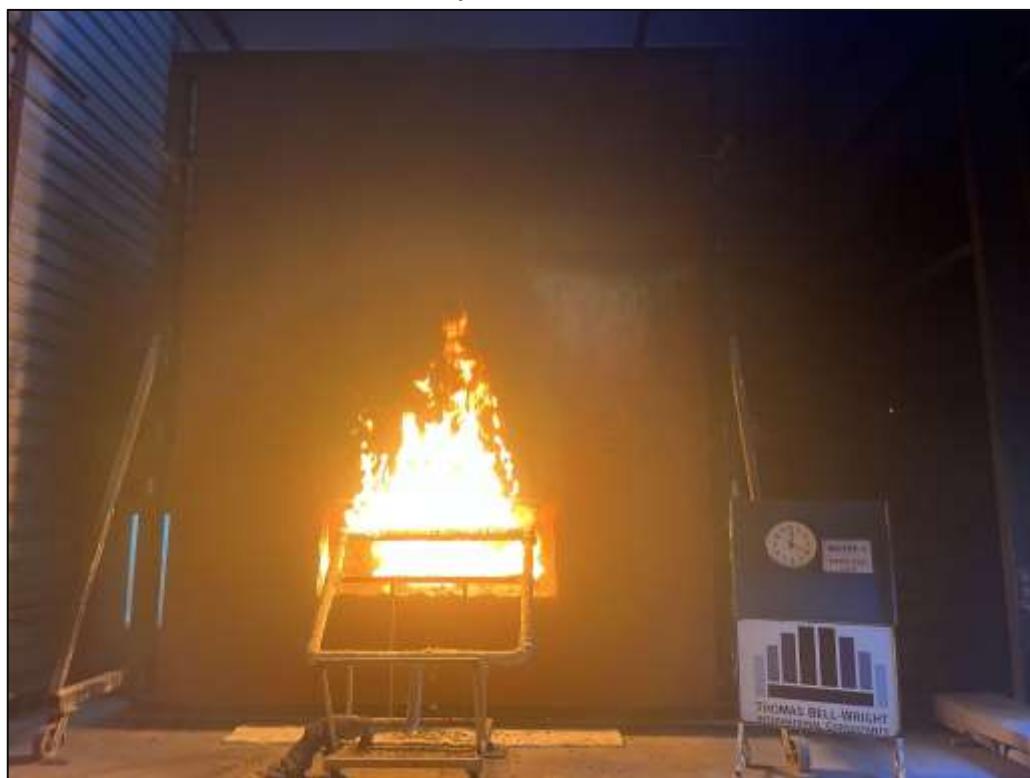
Picture 18: The specimen at 20:00 minutes.

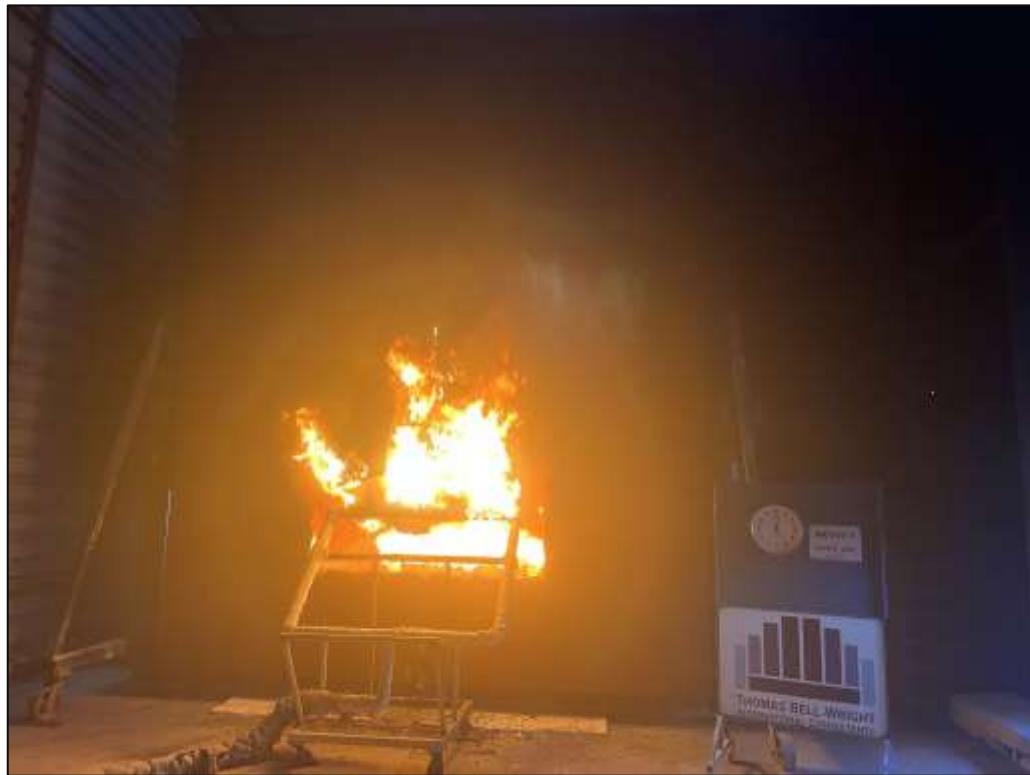
Picture 19: The specimen at 25:00 minutes.

25:00	The specimen was stable.
25:25	A portion of the panel 07L, was witnessed dislodging, resulting in the exposure of the inner components of the assembly.

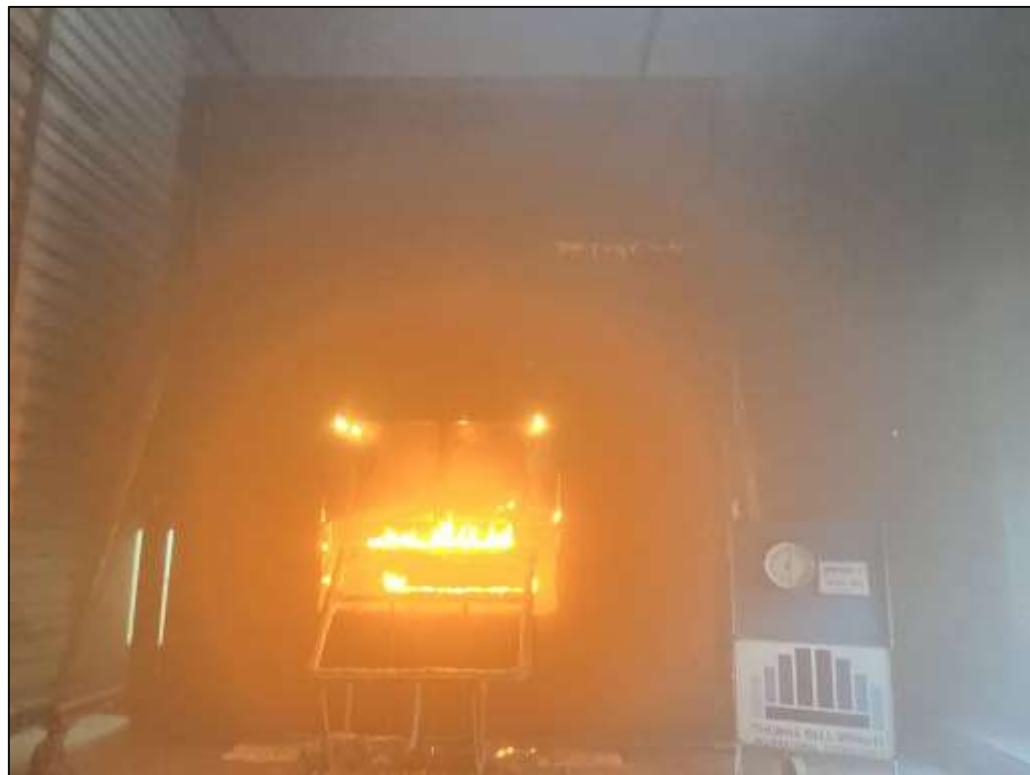
Picture 20: The specimen immediately after the gas was shut off, starting the observation period.

27:55	The horizontal cavity fire barrier located at 2.5 feet was slightly exposed.
30:00	The specimen was stable, the test was stopped and gas shut off, as per the NFPA 285 Standard, and the 10-minute observation period began.

30:01	Residual flaming was observed on the horizontal joints approximately at 2.5 feet in line with the window jambs, on the surface of the horizontal cavity fire barrier located on the right hand-side and on the left window jamb.

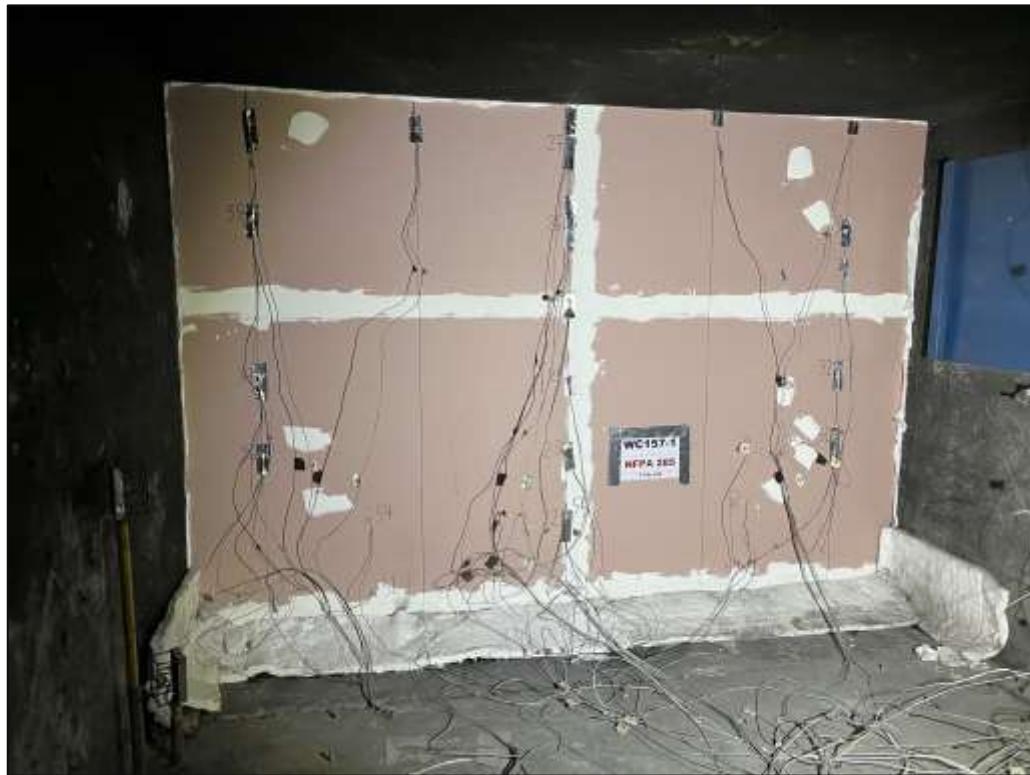
Picture 21: The interior of the base wall in the second-floor test room at the end of the test.

No damage was observed to the interior of the base wall in the second-floor test room. The gypsum within the first-floor test room was badly burned, but still intact.
