TEST REPORT FOR FIRE PROPAGATION CHARACTERISTICS OF EXTERIOR WALL ASSEMBLIES

4mm thick WELLBOND-A2 Aluminium Composite Panel (ACP) Cladding Assembly.

NFPA 285: Standard Fire Test Method for Evaluation of Fire Propagation Characteristics of Exterior Wall Assemblies Containing Combustible Components, 2019 Edition.

Test Reference No: WC157-1

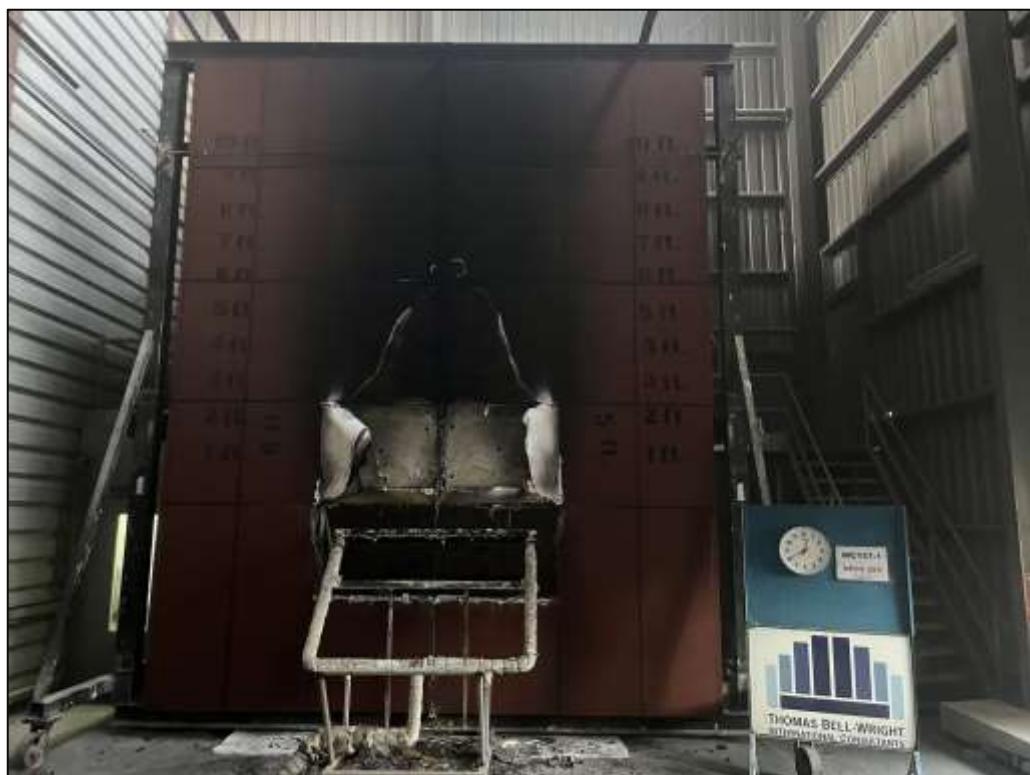
Picture 20: The specimen at the end of the observation period and end of the NFPA 285 test.

Soot stains were observed centrally along the height of the specimen from the window head. Mineral wool insulation was exposed up to approximately 2.5 feet above the window head. The horizontal cavity fire barrier located just above the window head was exposed and slightly damaged. The base of the horizontal cavity fire barrier located at 3 feet above the window head was visible. The ACP coating had peeled off till a maximum height of 6.5 feet above the window head. Window flashing had completely deformed, melted and were barely in place.

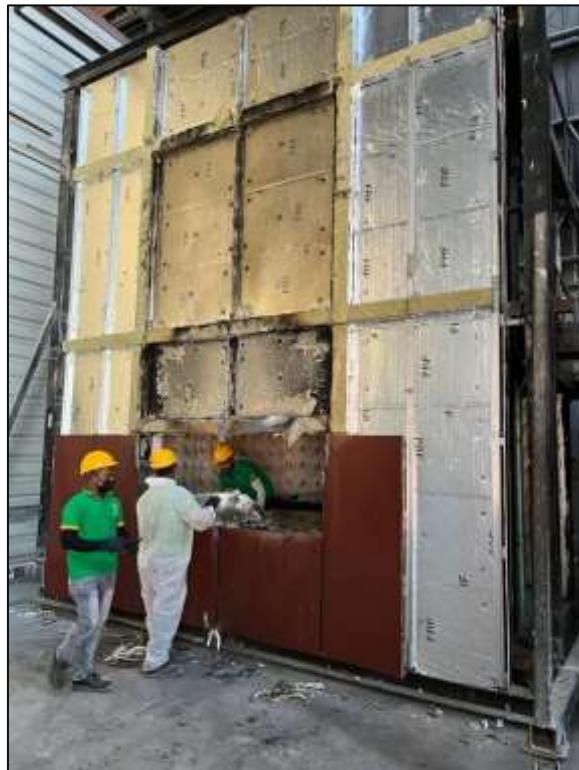
Picture 21: Dismantling view.

Damage was largely limited to the window head section and upon removal of the remaining intact panels around the exposed area, high smoke damage was observed on the backside of the panels 07L & 07R. Light smoke stains were observed on the top horizontal cavity fire barriers.

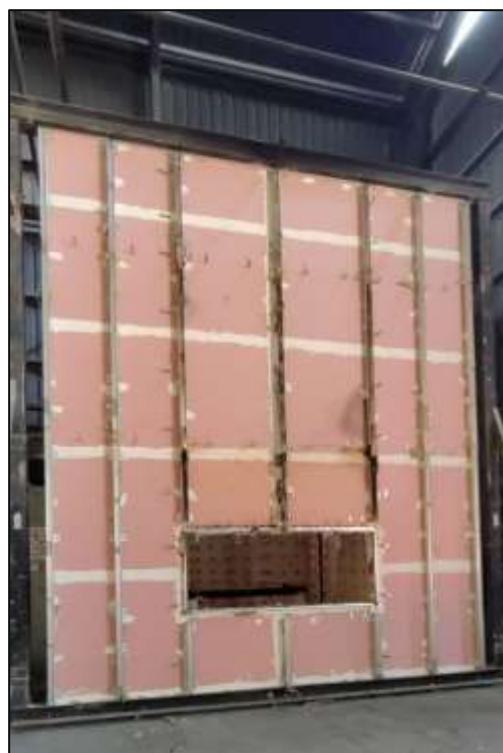
Picture 22: Assembly after the removal of panels and insulation system.
